July 8, 2025

RE:           Lead-Based Paint Survey 12 Buildings  
              4 Lazy F Ranch  
              4 Lazy F Ranch Road  
              Moose, Wyoming  
              Northern Industrial Hygiene Project No. 999-5237

This letter report provides the summarized results of the lead-based paint (LBP) survey conducted by Chris Hust of Northern Industrial Hygiene, Inc. (Northern) on May 20, 2025, and May 21, 2025, at the above referenced site. The survey was conducted to identify potential LBP and lead-containing paint (LCP) that may be present on the interior and exterior finishes of the 12 buildings that will be impacted by the upcoming renovation project.

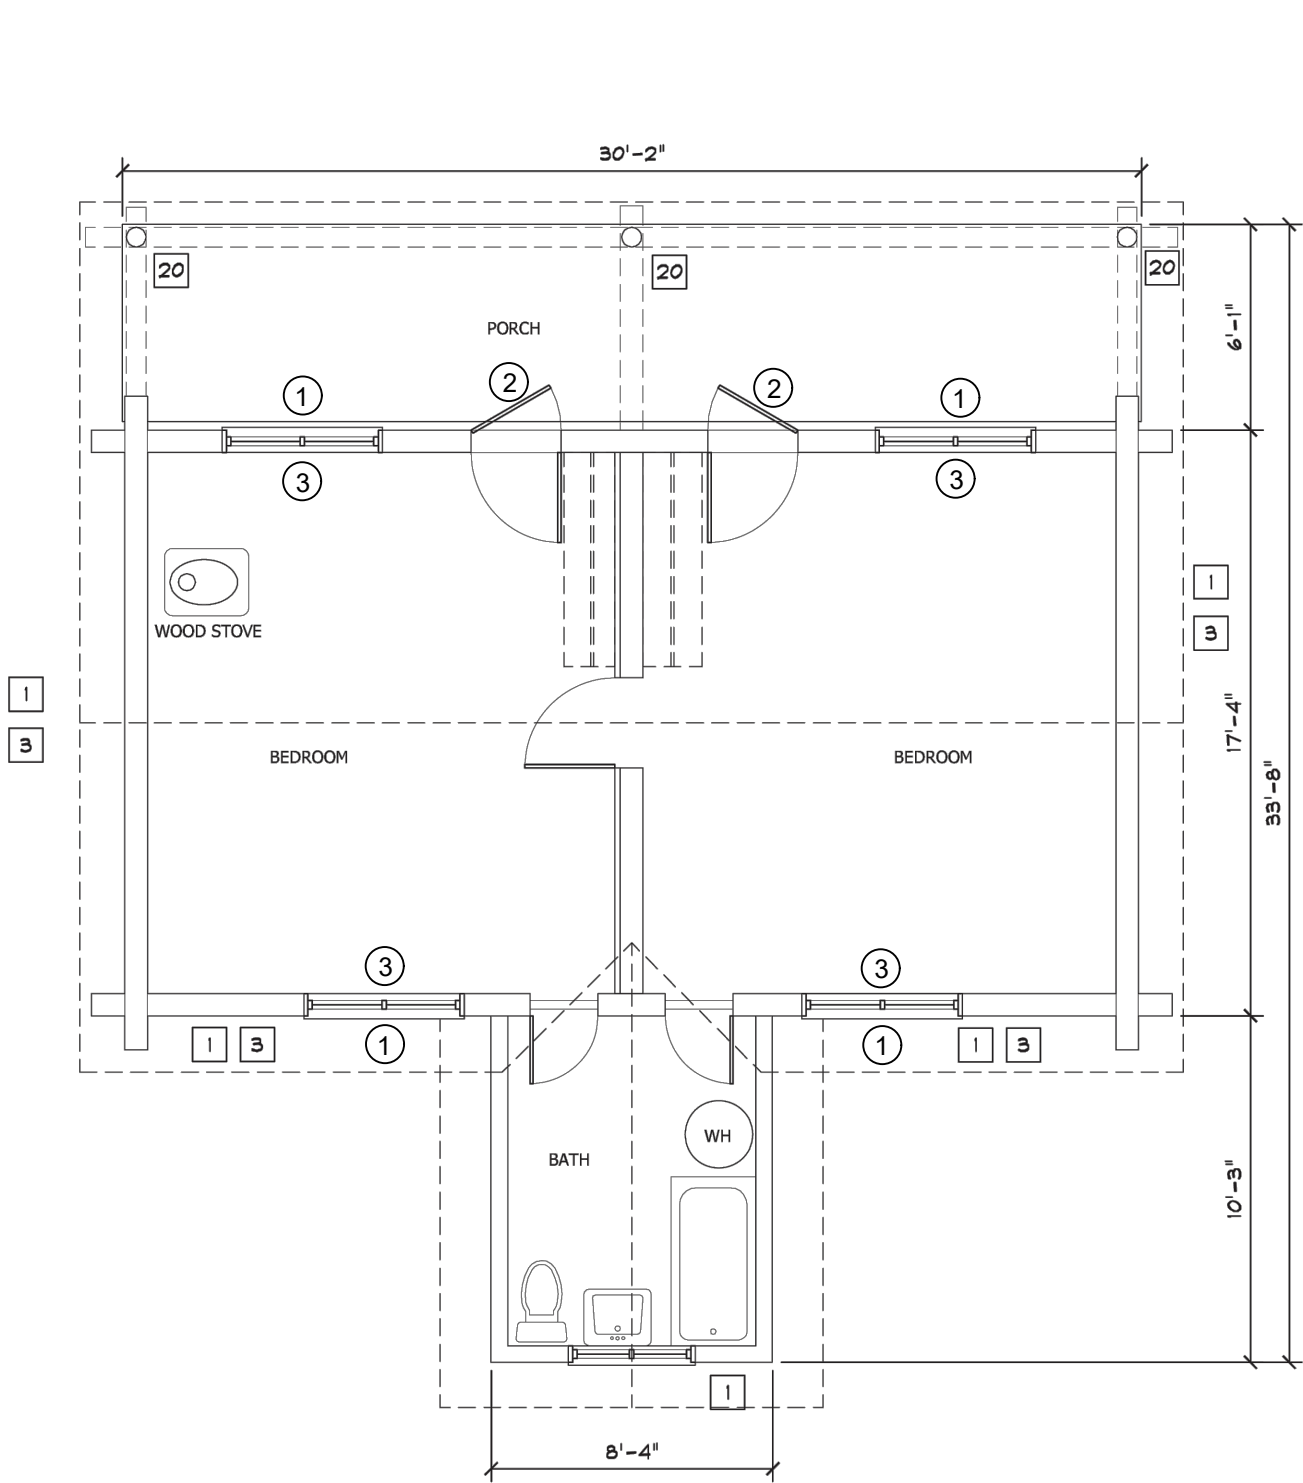
LBP LOCATION DRAWING  
END CABIN

- ① LBP on Exterior Window Components
- ② LBP on Exterior Door Components
- ③ LBP on Interior Window Sash

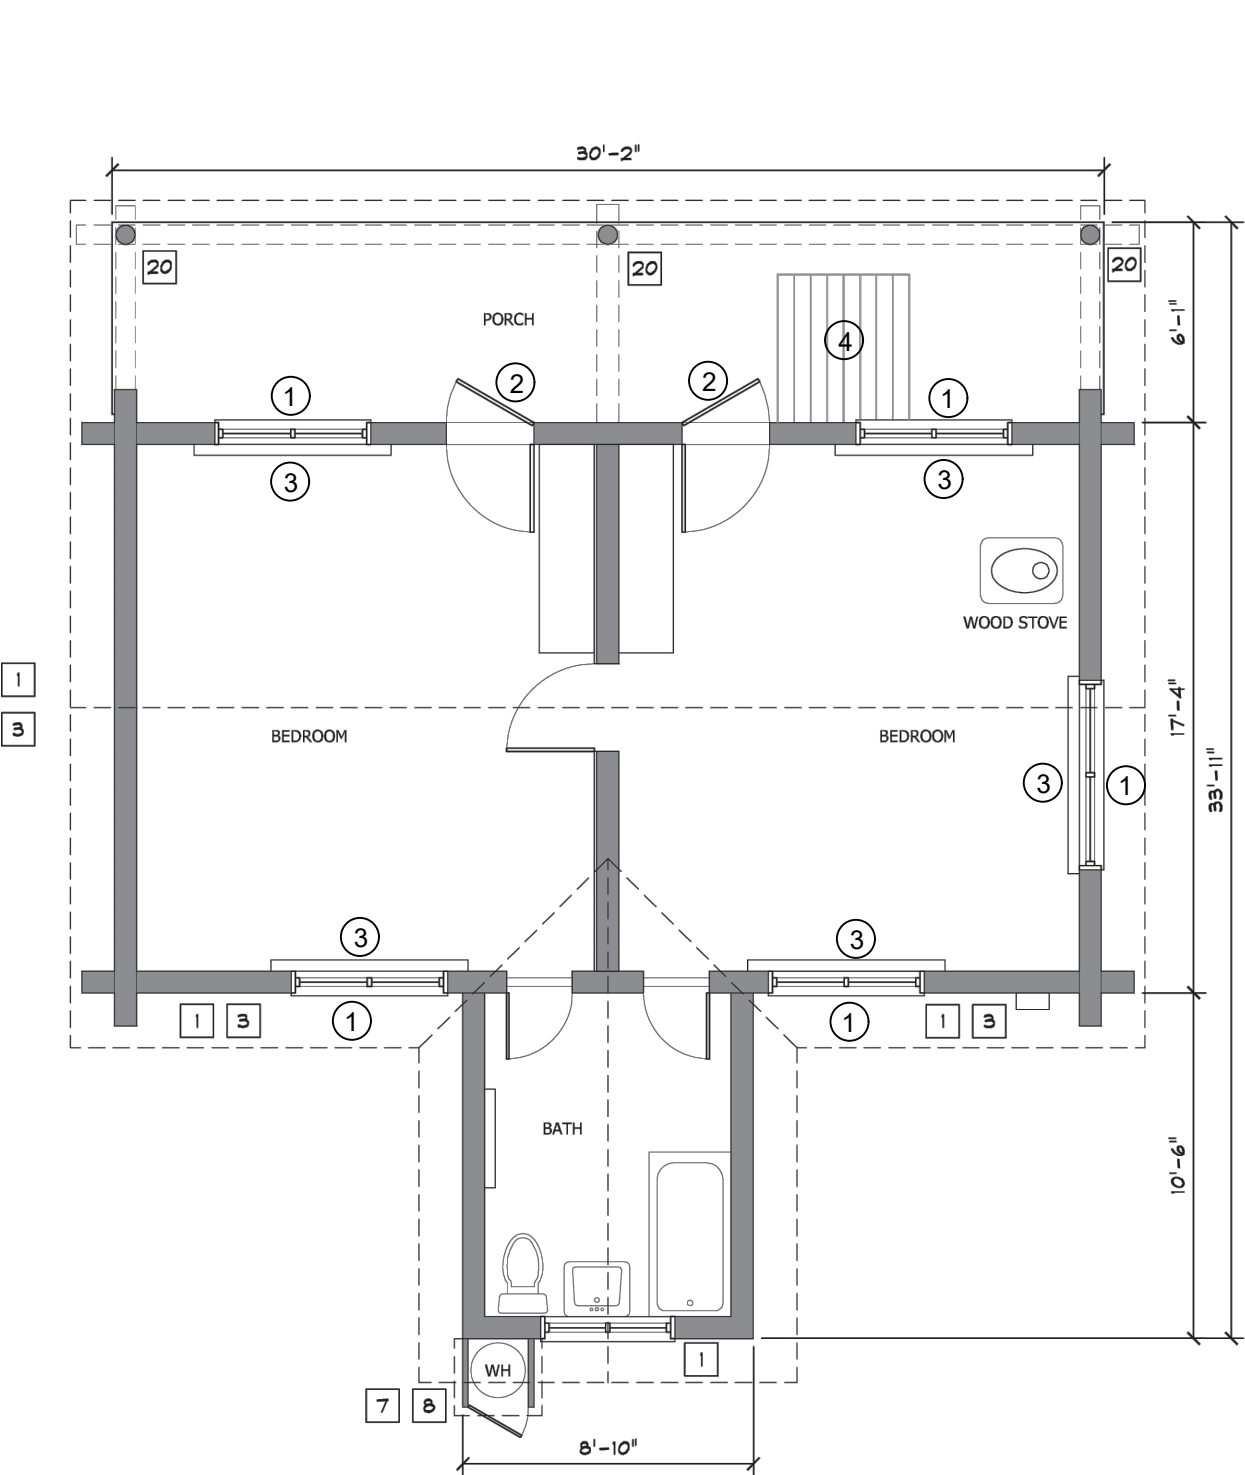
LBP LOCATION DRAWING  
MRS. OLIVER'S CABIN

- ① LBP on Exterior Window Components
- ② LBP on Exterior Door Components
- ③ LBP on Interior Window Sash
- ④ LBP on Crawlspace Hatch

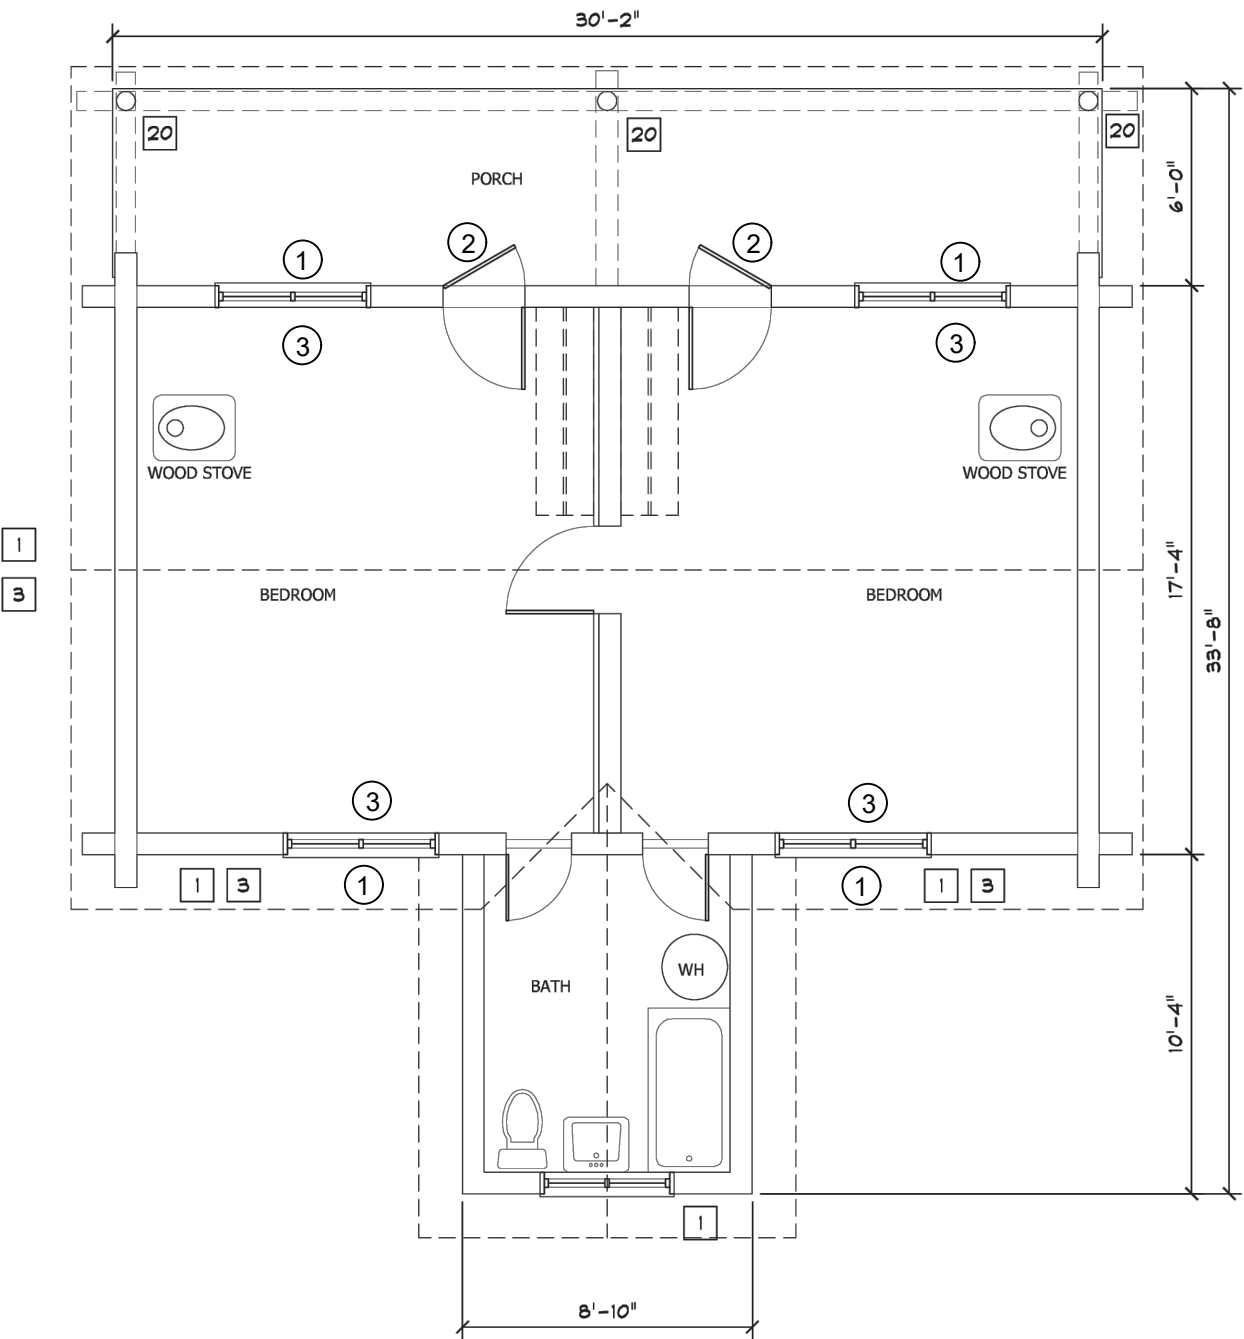
LBP LOCATION DRAWING  
MIDDLE CABIN

- ① LBP on Exterior Window Components
- ② LBP on Exterior Door Components
- ③ LBP on Interior Window Sash

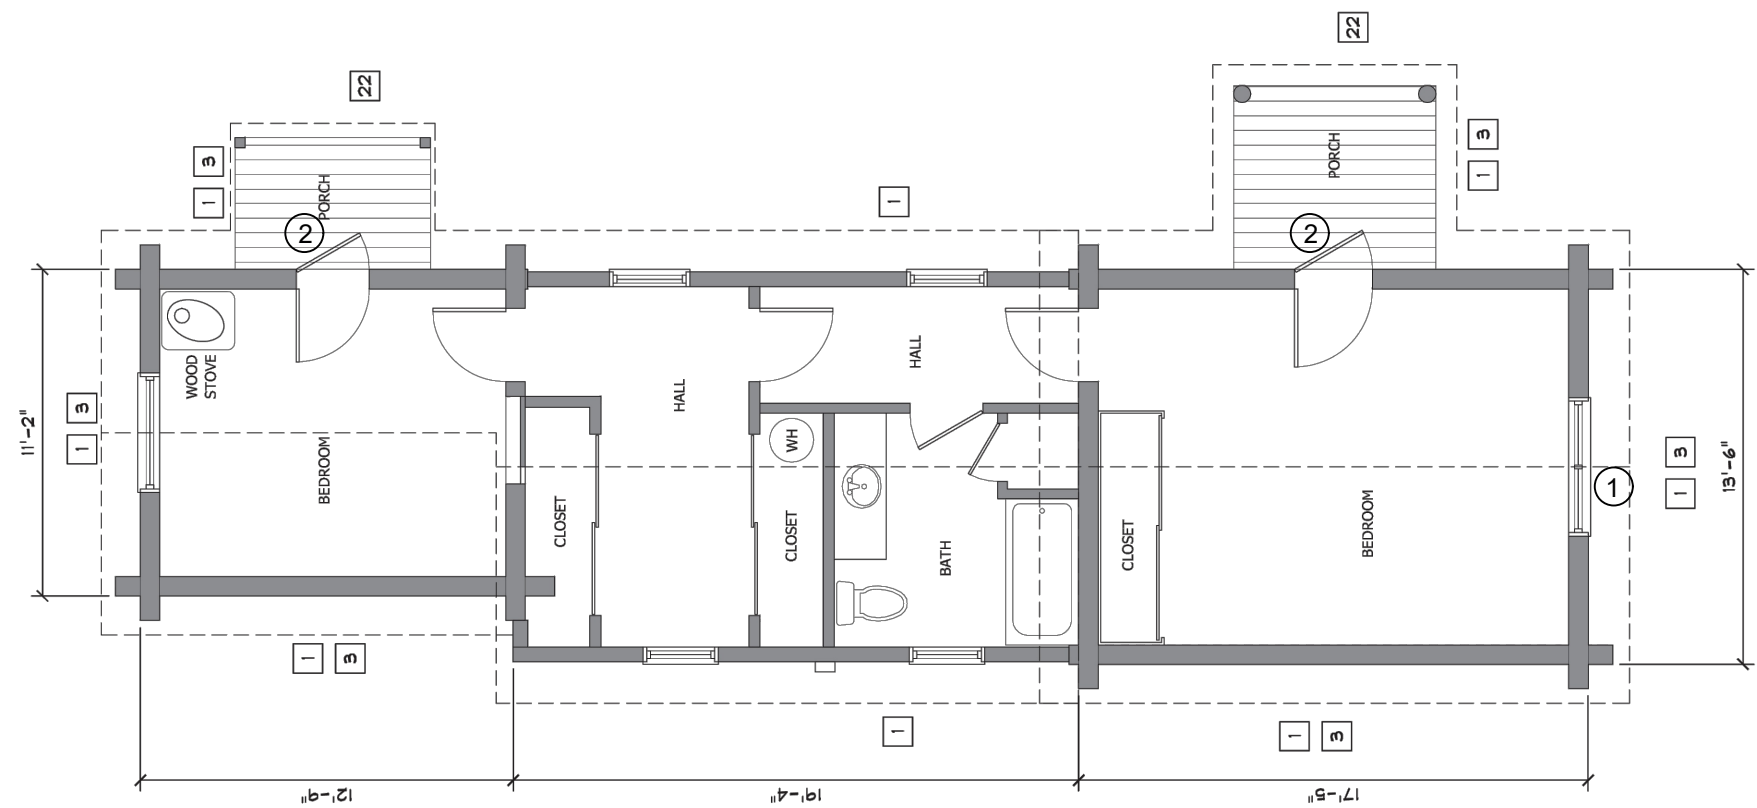
LBP LOCATION DRAWING  
NURSE'S CABIN

- ① LBP on Exterior Window Components
- ② LBP on Exterior Door Components

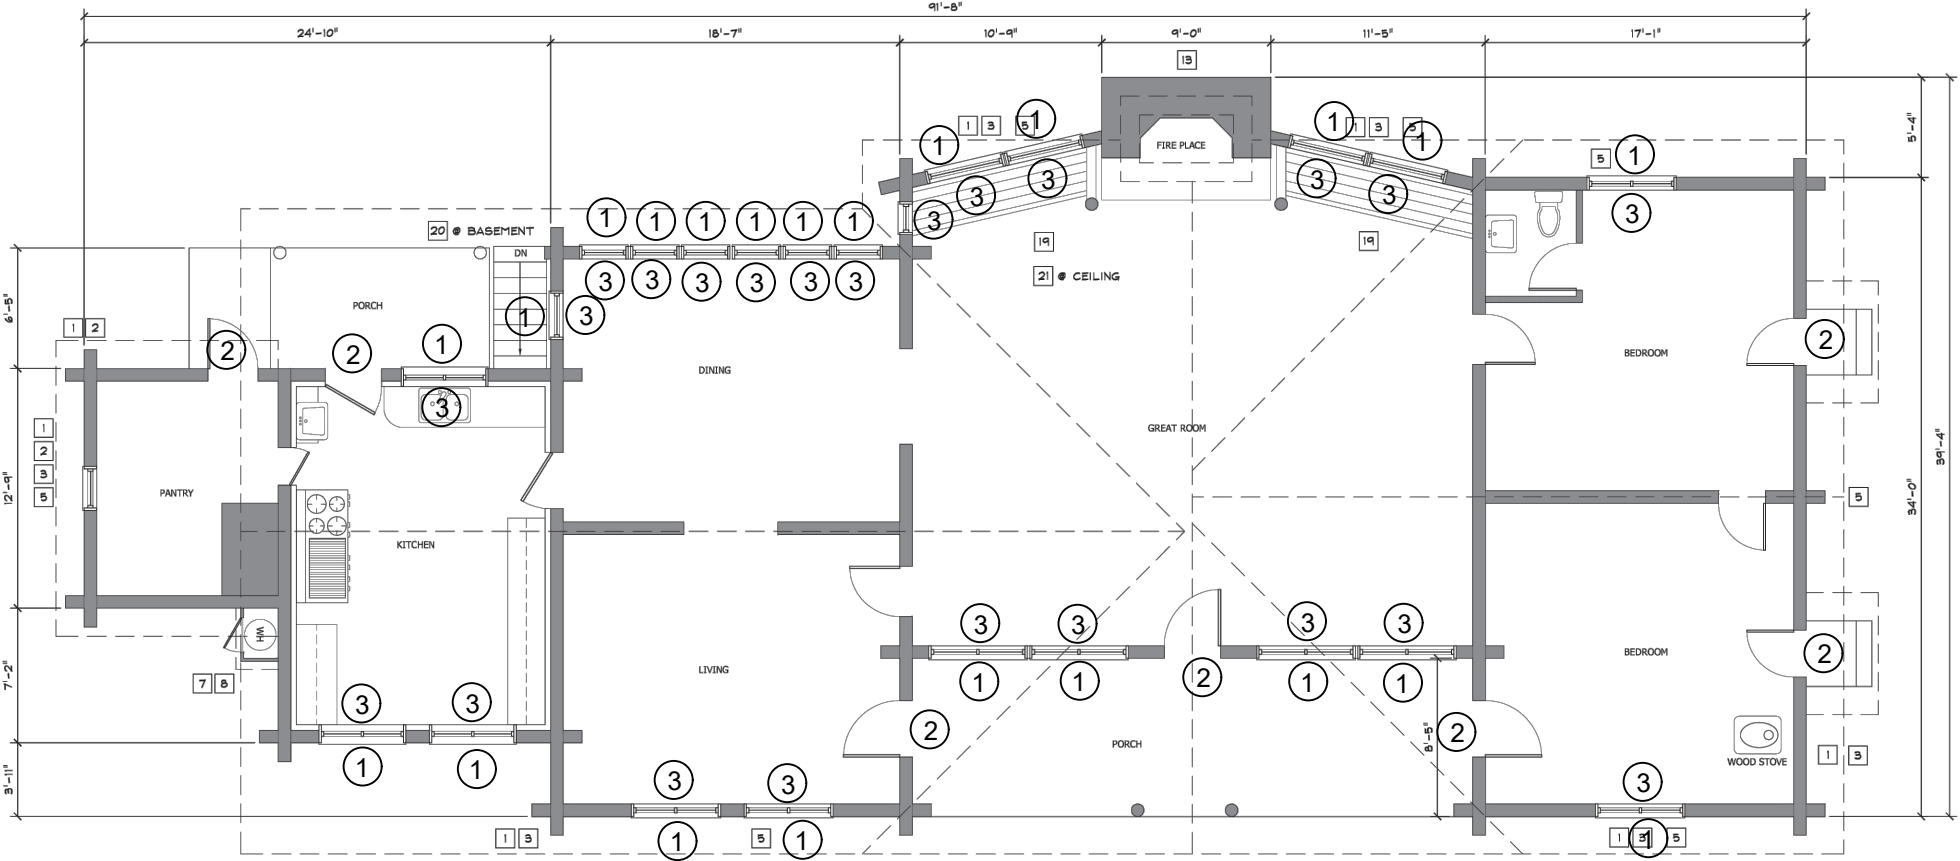
LBP LOCATION DRAWING  
MAIN LODGE

- ① LBP on Exterior Window Components
- ② LBP on Exterior Door Components
- ③ LBP on Interior Window Components
