# Redwood Water Tanks

## Hawai'i Volcanoes National Park

### Trip Report and Preliminary Treatment Recommendations

January, 2018

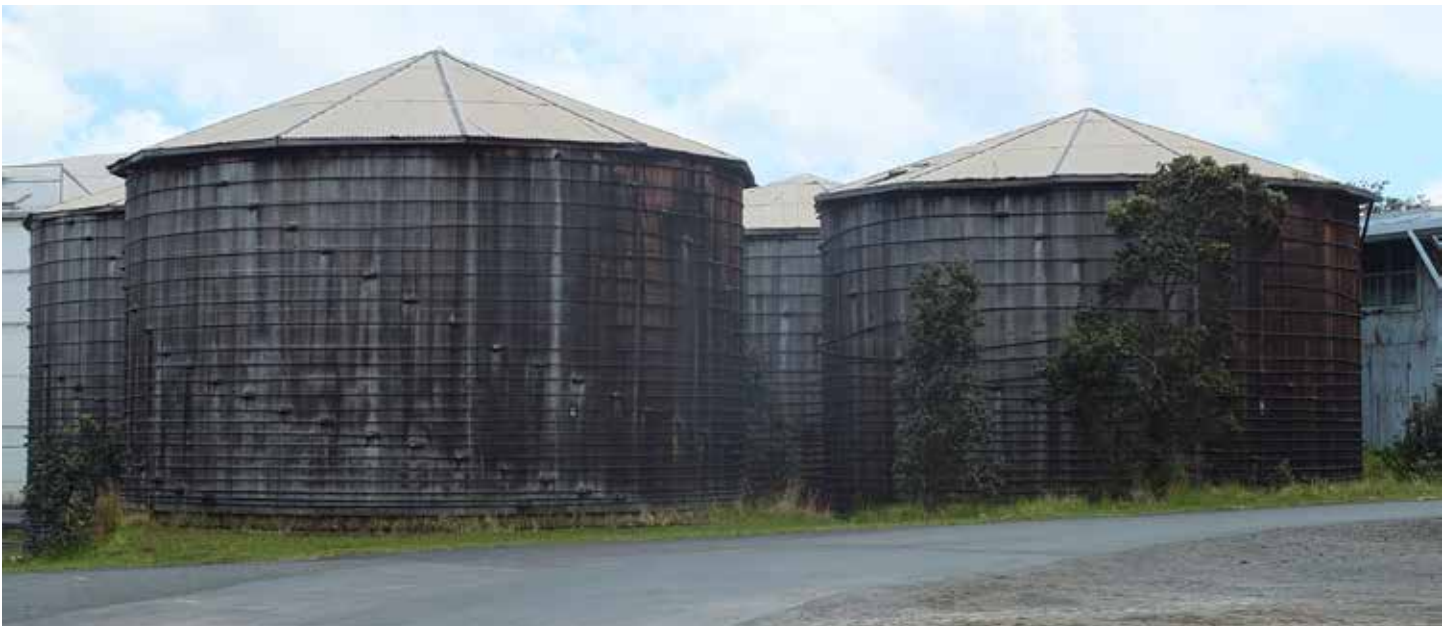
*Figure 2: General view of the remaining redwood tanks. The tanks all hold 100,000 gallons except the tank on the front left which is smaller than the others, holding only 80,000 gallons.*

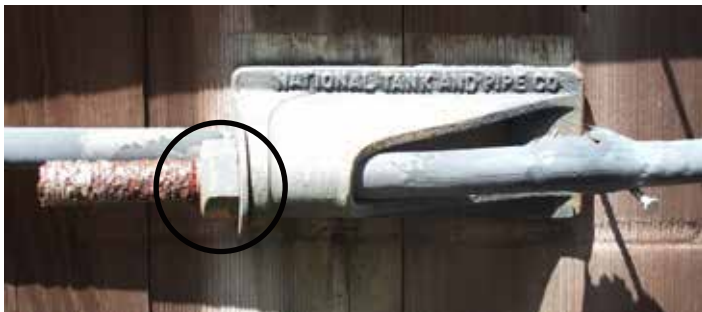
*Figure 5: Close-up view of one of the lugs that connects the 5 sections of each steel band. The threaded connection with the nut (circled) allows the bands to be tensioned so that they compress the wood staves and resist the outward thrust of the water.*

In addition, the threaded ends on all of the bands have corroded, making it impossible to turn the nuts that are used to tension or remove the bands. (Figure 5) As a result, in order to tension, or to remove and replace any band sections, they will have to be cut.

Each band is made from 5 separate, approximately 20-foot-long sections that are joined with bolted connections at steel lugs. (Figure 5) Concern has been expressed that when a band corrodes all the way through, it may snap, flying out from the tank with the potential to cause injury or damage. Because there is no water in any of the tanks, and therefore there is no outward pressure, the bands are no longer in tension and it is highly unlikely that they will snap. Instead, they will more likely just break apart and remain in place as long as the nails that are holding them remain intact.

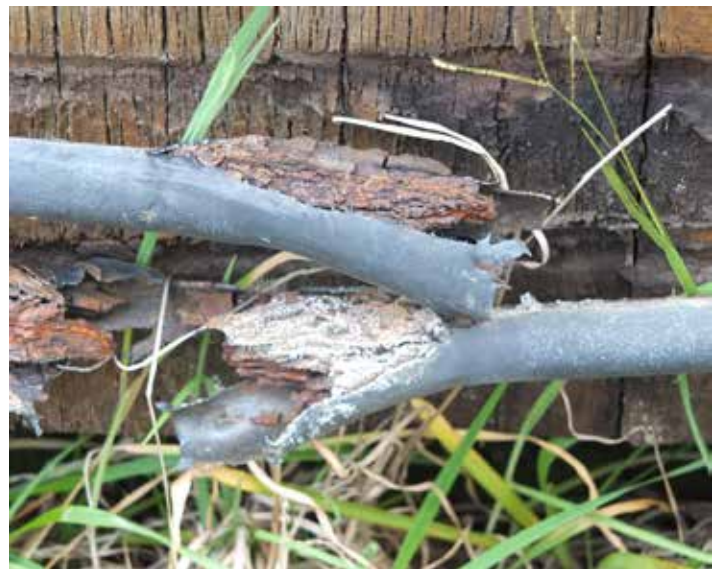
One significant exception is the mild-steel bands which are uniformly failing. Mild steel is not an alloyed steel and therefore does not contain significant amounts of anything other than iron. The lack of alloying elements, such as those found in stainless steels, means that the iron in mild steel is subject to oxidation (rust) if not properly coated.

Given the humid subtropical climate of HAVO coupled with the presence of corrosive sulfur dioxide from volcanic gases, the steel in the tank bands is showing significant corrosion, and in some places have rusted completely through. (Figure 6)

*Figure 6: The damp climate, coupled with the presence of sulfur dioxide from volcanic gases, has caused the mild-steel in the tank bands to corrode. Here the band has rusted completely through.*

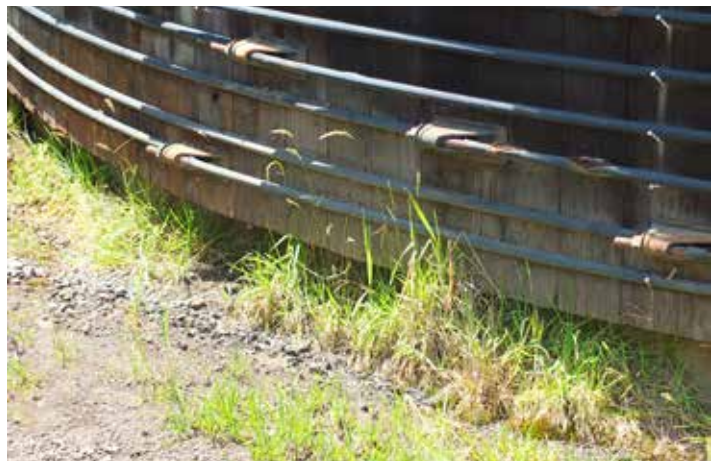
Despite some surface erosion, the concrete appears to remain in good condition. Soil deposition has raised the grade around the tank foundations, brining it up to and over the level where the foundations step back. This has allowed moss and/or grass to grow right up to the base of the tanks creating a situation where the end grain of the staves has become susceptible to prolonged exposure to moisture. (Figures 7, 8 & 9)

*Figure 8: Changes in soil levels have covered the bottom halves of the footings allowing grass to grow right up to the base of the tanks.*

Grade should be adjusted around the foundations to restore a condition like that shown in Figure 3, where the soil level is held below the level of the step-back. At the same time, it is important to slope the grade away from the base of every tank so that water will drain away from the foundations and not pool against the foundation. All accumulated soil, grass, and moss should be removed from the top of the step-back. This should be kept clear and clean so that the bottom ends of the staves are not exposed to additional moisture and can quickly dry when they are wetted.

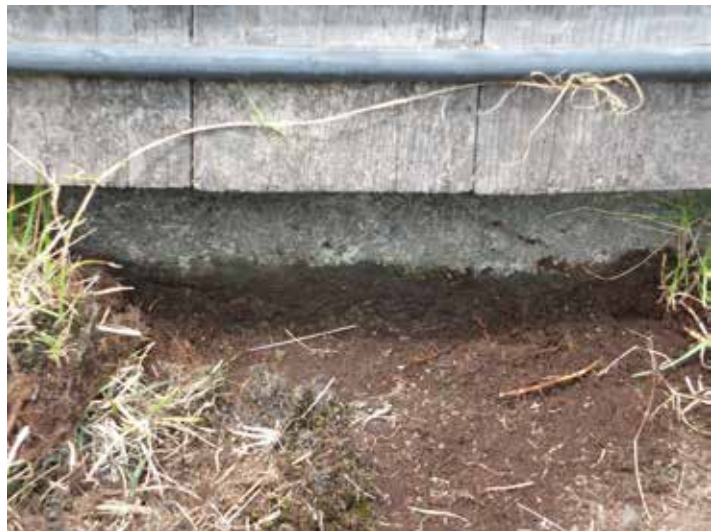
*Figure 9: Close-up of the base of a tank showing where soil had covered the foundation's step-back allowing grass to grow on top of the concrete. This condition can potentially accelerate the deterioration of both the wood staves and the concrete.*

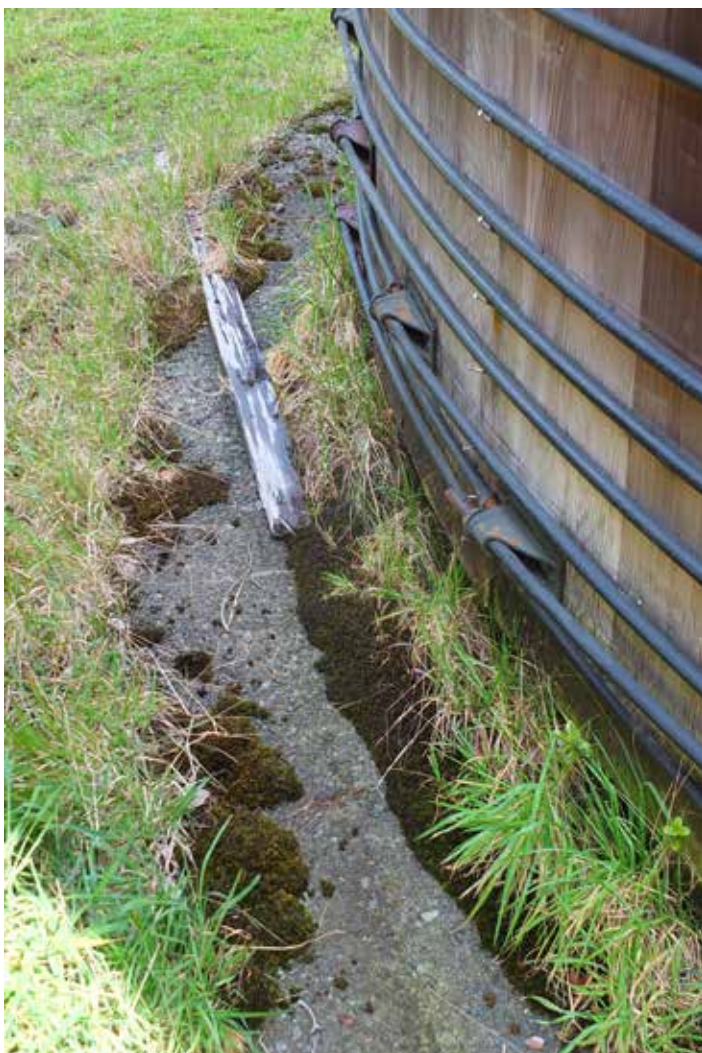
*Figure 7: At the base of the tanks, the concrete footing steps back approximately at grade level. Soil deposition has both raised the grade around the tanks and allowed soil to accumulate on top of the footing, supporting the growth of both grass and moss. This will accelerate the deterioration of both the concrete footing and wood staves.*

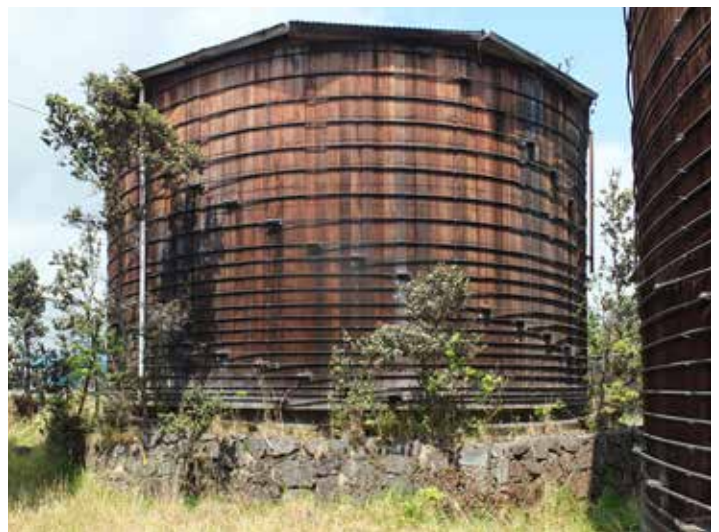
Because the tops of all the tanks must be at the same height in order for them to work as a system, the smaller 80,000-gallon tank (T8) has been placed on an earthen platform that is supported on the south by a low stone retaining wall. (Figure 10)

*Figure 10: Tank 8 sits on an earthen platform retained by a rubble stone wall*

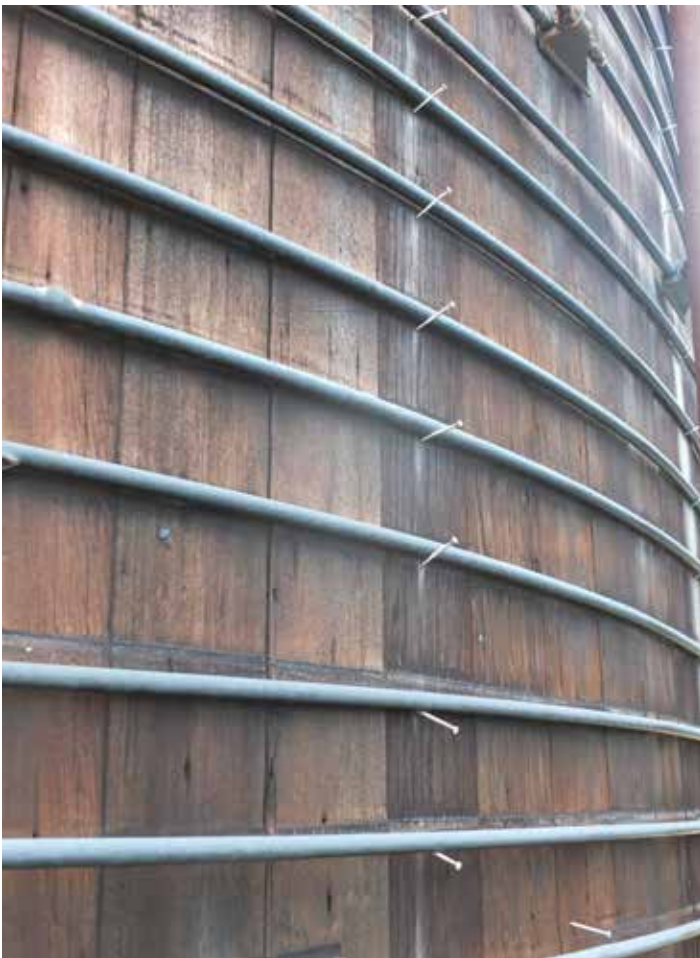
The staves form the wall of the tank, support the roof of the tank, and contain the water when the tank is filled. As such, staves are a primary structural component of the tank. (Figure 11) The

*Figure 11: Close-up of tank staves and bands. Note that because the tank is empty there is no horizontal hydrostatic pressure to push outward and hold the steel bands in place. Nails have been used to prevent the bands from slipping down.*

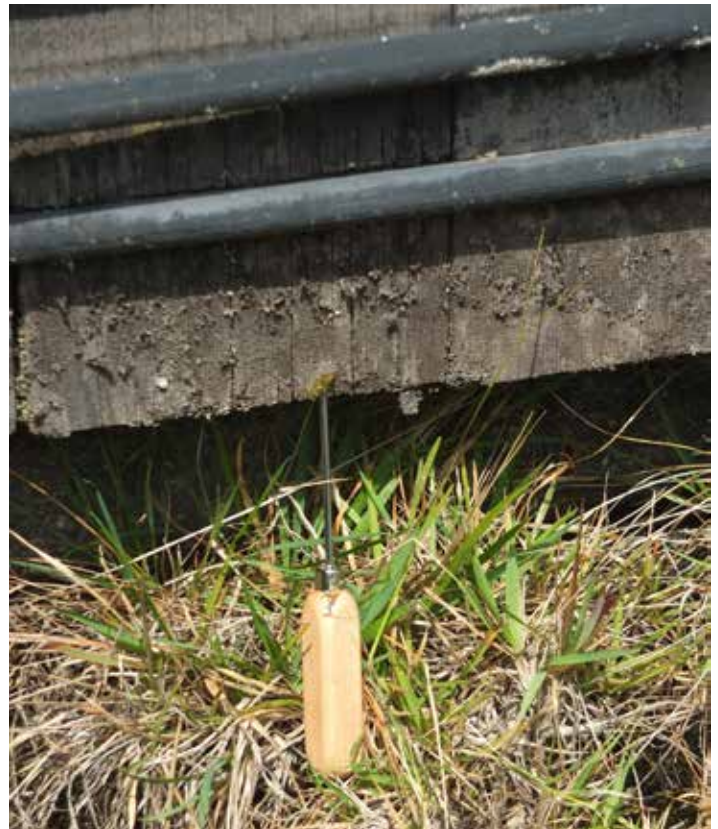
staves of the HAVO tanks, made from clear redwood, possess a natural decay resistance. When inspected from the ground, the accessible portions were found to be good condition with no apparent, significant issues. (Figure 12)

*Figure 12: Wood is most vulnerable to water penetration at the end grain, yet even in areas where grass was growing directly under the ends of the staves, an icepick would penetrate less than an eighth of an inch, indicating that the staves remain in good condition.*

Additionally, where moss, mildew, fungus, or lichens are growing on the wood (Figures 12 & 13),

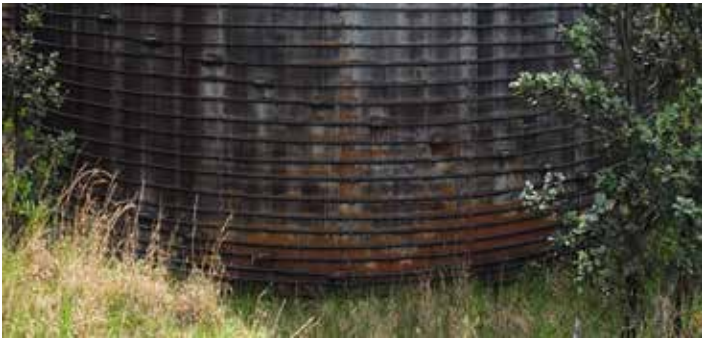
*Figure 13: As seen here, close proximity of vegetation, including grass, shrubs, and trees can create microclimates that prevent drying and encourage the growth of moss and fungus on the wood staves. The area around the tanks should be kept clear of vegetation and the grass should be kept short.*

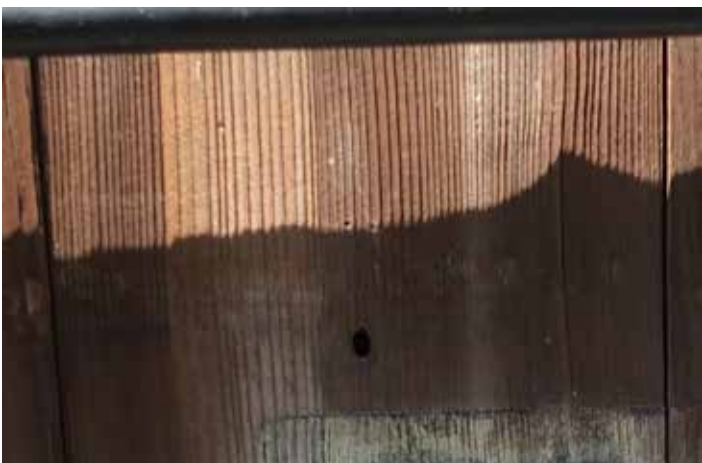
Additionally, ultraviolet (UV) radiation will break down the lignin in the wood, resulting in surface loss. This is often expressed as “raised grain”. (Figure 14) While this was not observed to be a

*Figure 14: Ultraviolet degradation is one cause of raised grain, as seen here.*

major problem, some staves were showing areas of raised grain, and a more detailed inspection may reveal more evidence of this type of UV degradation.

If UV degradation is found to be a significant problem, there is a treatment that has been developed specifically for unfinished redwood that will protect it from UV radiation. (See Attachment 1) If, upon close inspection, significant surface loss is noted, it would be worthwhile to test this treatment on the tanks.

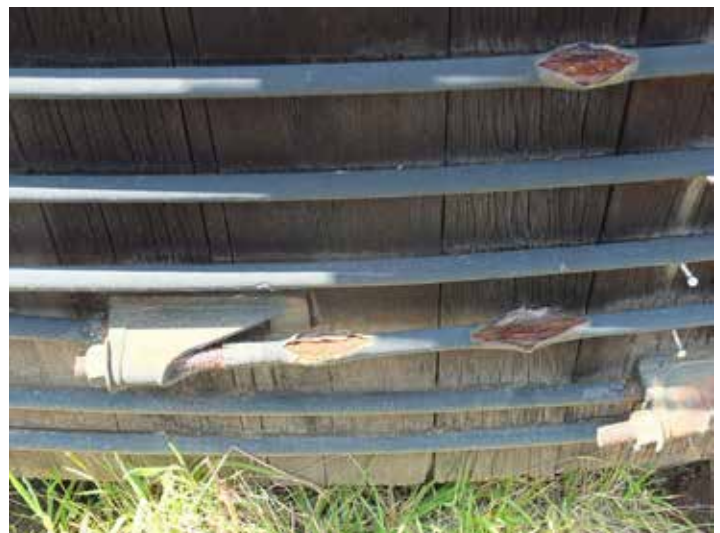
Five-part steel bands encircle each tank, spaced from 6 to 12 inches apart. (See Figures 3, 5, 6, 11 & 16) As already noted, many sections of the steel bands are in poor condition. The humid, sub-tropical environment coupled with the corrosive effects of sulfur dioxide from volcanic gases have had a devastating impact on the mild steel of the band sections, many of which have begun to corrode at multiple points around the circumference of the tanks (Figures 5, 6, 16 & 17).

*Figure 16: General view of tank bands showing areas of corrosion. Corrosion is widespread with a number of bands having rusted completely through. In addition, all of the threaded ends have corroded to the extent that the bands will need to be cut for them to be removed.*

Nevertheless, the corroded bands will need to be replaced and eventually all of the remaining bands will rust through and require replacement. Replacement is particularly urgent for the tank

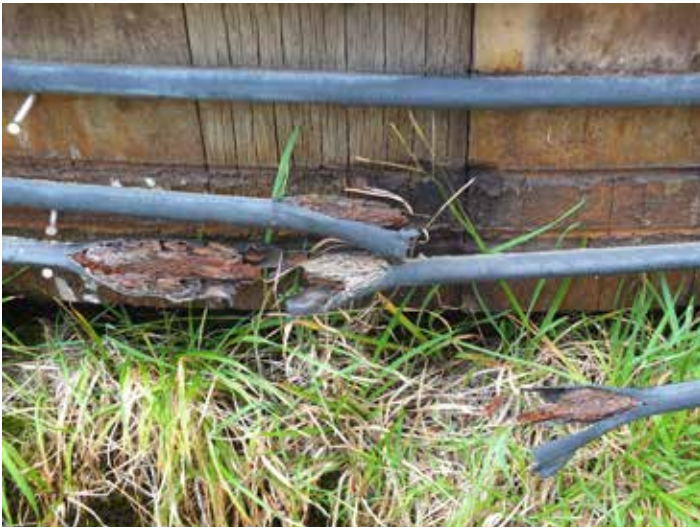
Currently, on at least one tank, the two bottom bands - which are critical for holding the bottoms of the staves in place against the concrete foundation - have both rusted completely through. (Figure 17) While this tank appears to remain stable, the failed bands have the potential to structurally compromise this tank.

*Figure 17: On one tank, both of the bottom two bands have rusted through. Because these two bands compress the staves against the concrete foundation, this tank may be structurally compromised. Compression at the bottom end of these staves should be reestablished as quickly as possible.*

that has lost both of its bottom two bands (Figure 17) because this may structurally compromise the tank. These bands should be replaced as quickly as possible. Replacement bands are available from the original manufacturer, National Tank and Pipe Company (now International Tank and Pipe Company) of Clackamas, Oregon.

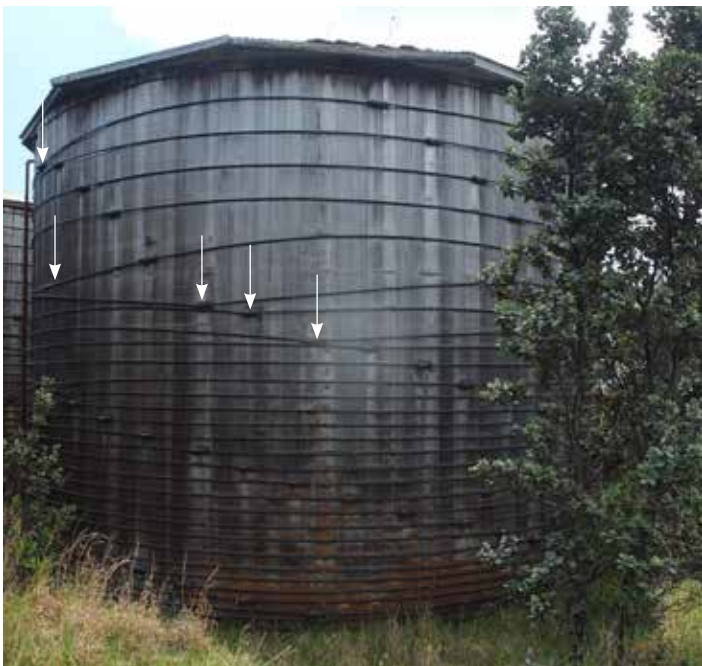
*Figure 18: Without the swelling and outward pressure that result from filling a tank with water, the circumference of an empty tank will shrink, releasing pressure on the steel bands. Where the nails supporting the bands have failed, the lugs and bands are slipping downward (arrows).*

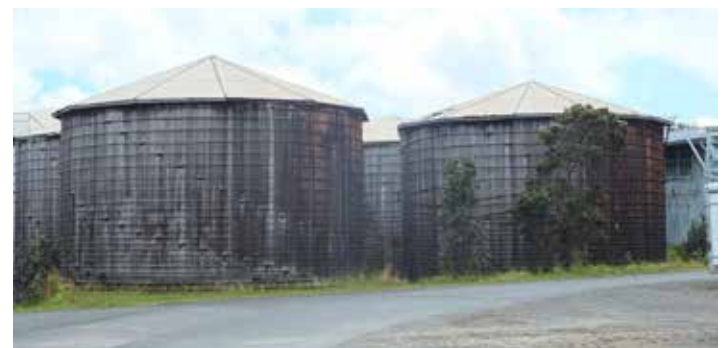
*Figure 20: Each tank has a 12-sided pyramidal roof that is covered with white corrugated metal panels. The tanks originally had wood gutters, sections of which remain on some tanks.*

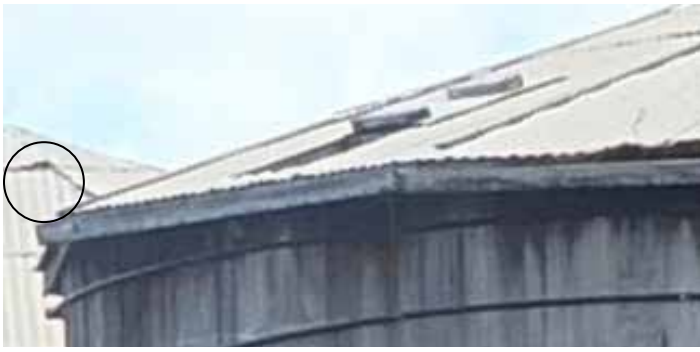
A visual inspection from the ground revealed white-finished corrugated aluminum panels with matching white metal hip caps. At least one of the tanks, Number 7, has a hatch in the roof to provide access to the interior of the tank. (Figure 21) It stands to reason that the other tanks also have roof hatches, but they were not observable from the ground.

*Figure 21: Tank 7 has an access hatch through the roof to provide entry to the tank interior. Logically every tank would need such a hatch. It may be that other hatches are not visible because they are closed (this hatch is open), and/or because they were not located in a position where the viewing angle allowed them to be seen from the ground. The corrugated aluminum roofing panels appear to be a light gauge and some may be working loose (circled).*

The roof hatch on each tank should be located and inspected. All hatches should be watertight,

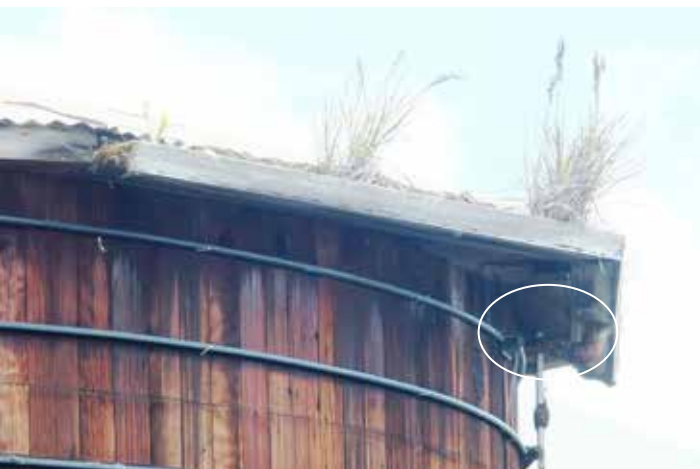
Some tanks retain sections of their original wooden gutters. (Figure 22) As can be seen in Figure 15, the wooden box gutters were installed directly against the fascia of the roof's eave. The gutter sections that remain are in poor condition, are choked with debris, and are supporting healthy vegetative growth. (Figure 22) On at least two tanks, the gutters have detached and are dangling

*Figure 22: Some tanks retain sections of the original wood gutters. What remains is in poor condition, is choked with debris, and is supporting healthy vegetative growth. Visible here is the gutter's "downspout" (circled). As might be expected, the rain that fell on the tank roofs was also collected and channeled into the tanks.*

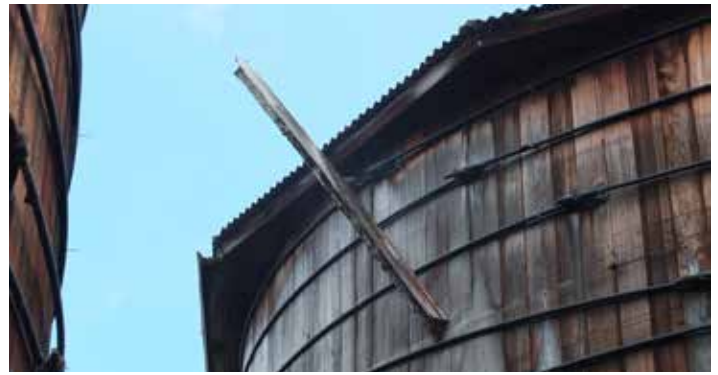
*Figure 23: The remaining gutters are in poor condition and some, as seen here, are detached and dangling precariously above the ground.*

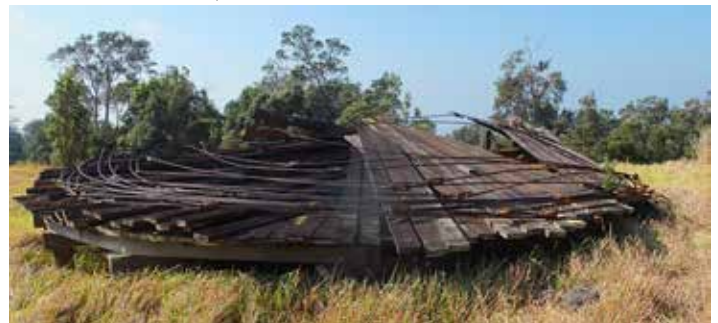
*Figure 24: Although a smaller tank in a different location, this clearly illustrates what can happen to an empty tank. With no water in the tank, there is no outward pressure on the staves. As the staves dry and shrink, gaps will open between the staves and, once there is enough space for one stave to fall inward, the rest will quickly follow.*

With the tanks preserved empty, it will also be critical to assure that there is adequate outward pressure on the tops of the staves to prevent them from collapsing inward. (Figure 24) Because all sloped roofs develop an outward thrust, it should be possible to use the roof structure to help achieve this objective.

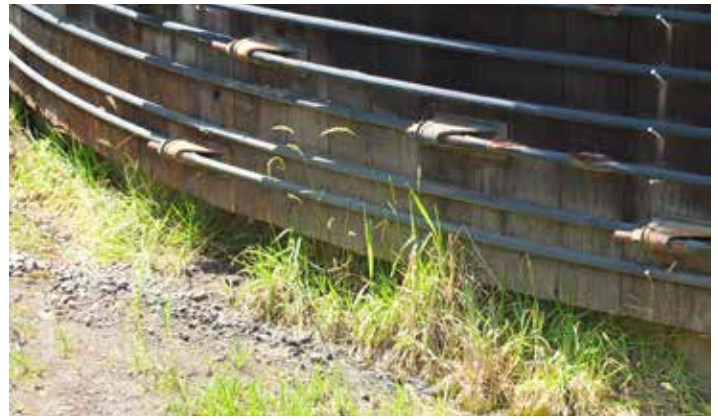
*Figure 26: The effects of “splash” are clearly visible here. The line of gravel on the ground that runs along the base of the tank shows where the water from the roof hits the ground. That water splashes back against the bottom of the tank, wetting the bottom ends of the staves. This allows moss and fungus to grow on the wood, leading to deterioration.*

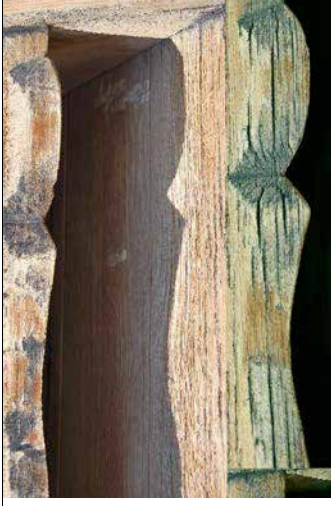
Fig. 1

Exposure to UV light results in the breakdown of the lignin matrix of wood, resulting in a loss of surface coherence, increased friability, and erosion. Earlywood is especially susceptible to erosion, and the process is often accompanied by detachment of wood fibers that appear as little "hairs" on the wood surface.

In Fig. 1, wood surfaces exposed to sunlight are noticeably eroded while shaded surfaces are smooth and largely intact. Under magnification, damage to the wood structure and disgregation of wood fibers from the surface are evident (Fig. 2). In Fig. 3, erosion is pronounced around the system of small checks that has developed on the end grain, as well as along earlywood layers of the wood surface.

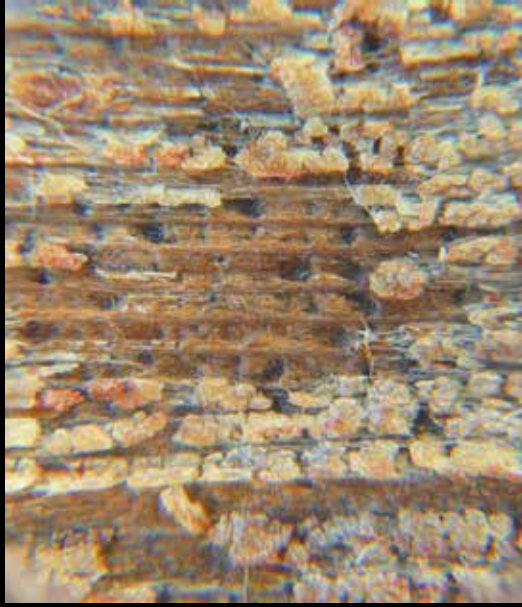
Before varnish removal

Dry cleaning (with a nylon-bristle brush) left a surface relatively free of old varnish, but disgregated as the result of UV exposure.

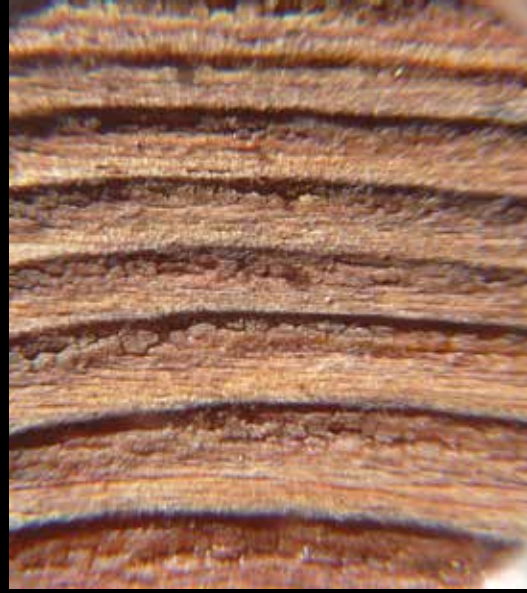
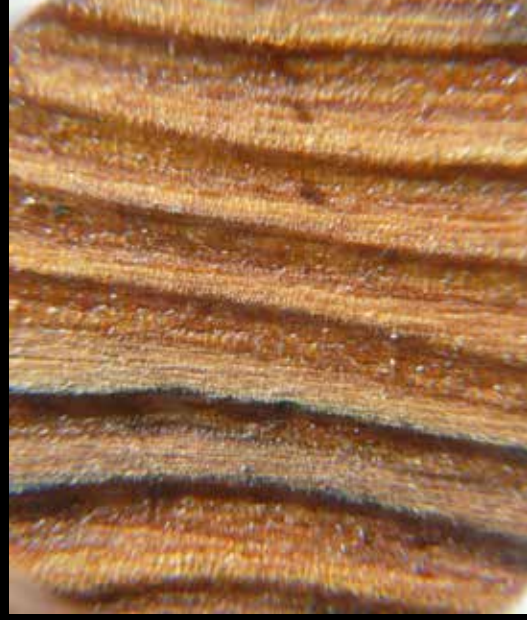
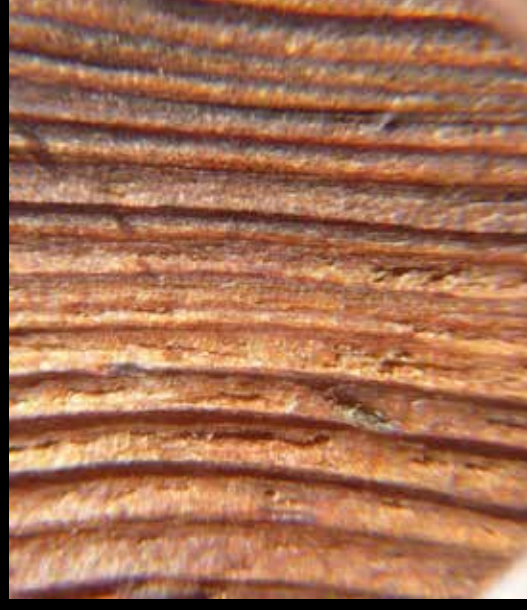
The consolidant can be effectively removed without adversely affecting the existing coatings by carefully selecting solvents (for mixing and cleaning) that do not dissolve the original varnish(es).

Before consolidation

After consolidation

After B-98 removal

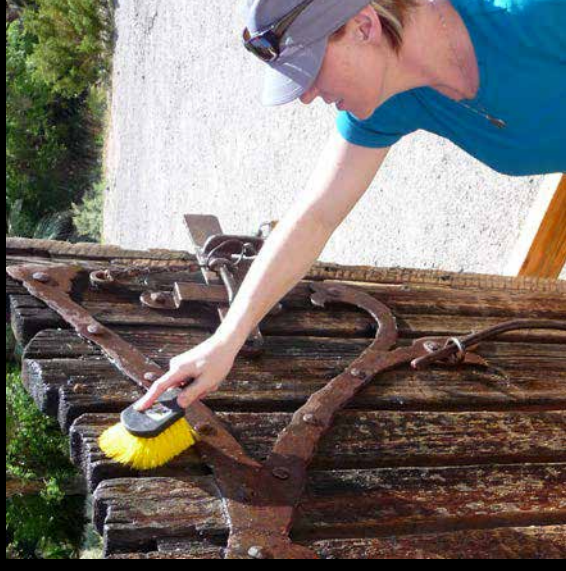
Remove loose varnish and debris with a coarse, nylon bristle brush. Brushing should be in the direction of the grain.

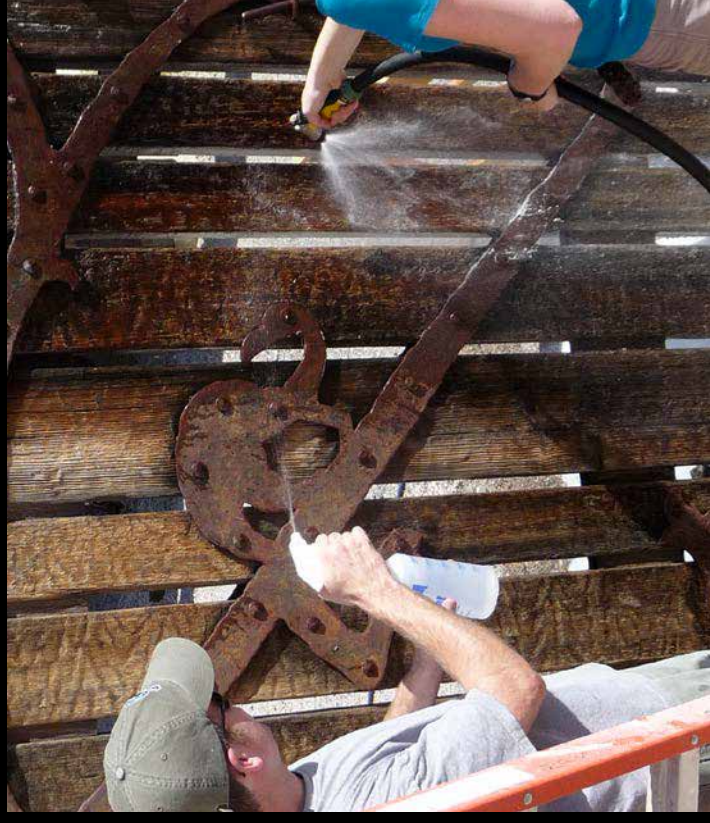
Loose embedded dirt, bird droppings, mildew and other accretions can be removed with water and a coarse nylon-bristle brush used in the direction of the grain. To remove mildew, use a 2% Vulpex solution in water and rinse thoroughly.

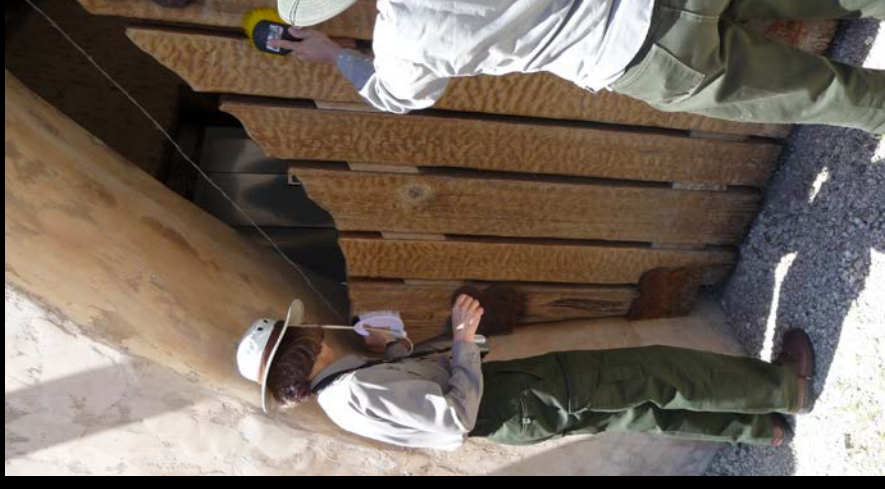
Coat the wood evenly with the consolidant. Add a heavier application to any areas that are particularly dry.

Allow B-98 to dry for 30 minutes before applying the second coat.

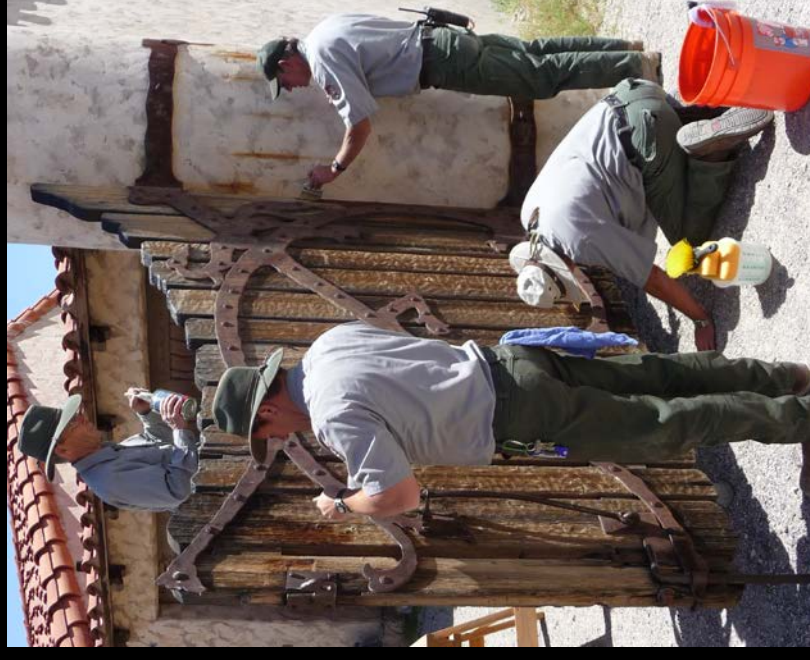
Consolidant: 3.5% B-98 (g/ml) in Ethanol (ETOH) w/ 8% Tinuvin 5151 by vol of B-98

- B-98 260ml (or 70g)
  - Ethanol (ETOH) 2000ml
  - Tinuvin 20.8ml
- A. Add dry B-98 slowly to ethanol (ETOH) and mix thoroughly (do not let the B-98 clump)
  - B. Allow to sit for 30 minutes
  - C. Add Tinuvin and mix thoroughly.
