# Geological Assessment Findings and Recommendations for Repairs and Corrective Actions

## *Blanchard Springs Caverns - Geological Assessment and Design*

### **United States Forest Service**

### **Golder Associates Inc.**

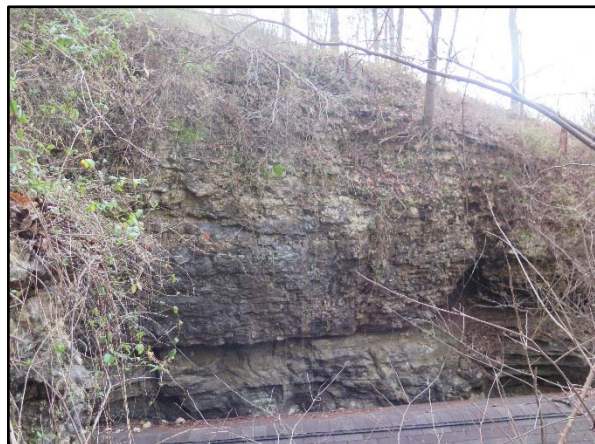
The Boone Formation has an unconformable contact with the underlying Chattanooga Formation and is described as a fine to coarse grained fossiliferous limestone with interbedded chert. This unit is typically light to medium gray on fresh surfaces and weathers to a dark gray. This unit is known throughout the region for having frequent springs and sinkholes. The Boone Formation is present in the natural roof portions of the Dripstone Cave. Additionally, this unit is present in unstained exposures just outside of the Dripstone Cave exit. In this area, the unit is a medium strong, slightly weathered limestone with very thin beds and frequent chert nodules.

**Figure 3:** Boone Formation outside of Dripstone Trail exit

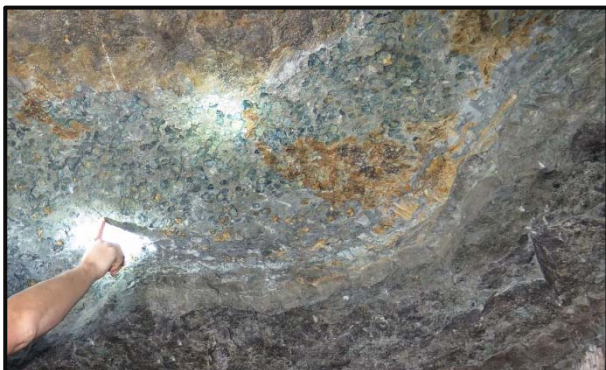
**Figure 4:** Upper portion of the St. Joe Member in the roof of the bypass tunnel

In the Dripstone Trail, the St. Joe Formation is present at or within the roof in the entrance to the cave, the bypass tunnel and the exit from the cave. The Upper portion of the St. Joe Formation is a distinguishable bed in each of the areas due to the presence of the green spheres of clay like material. In some areas, this unit has undergone moderate weathering and is very weak to weak. There are also trace amounts of pyrite cubes. Below the upper clayey member is an approximately 2 to 5 foot-thick thinly bedded limestone with frequent fossils and calcite mineralization that was slightly weathered and was much stronger than the upper member, with a medium strong strength.

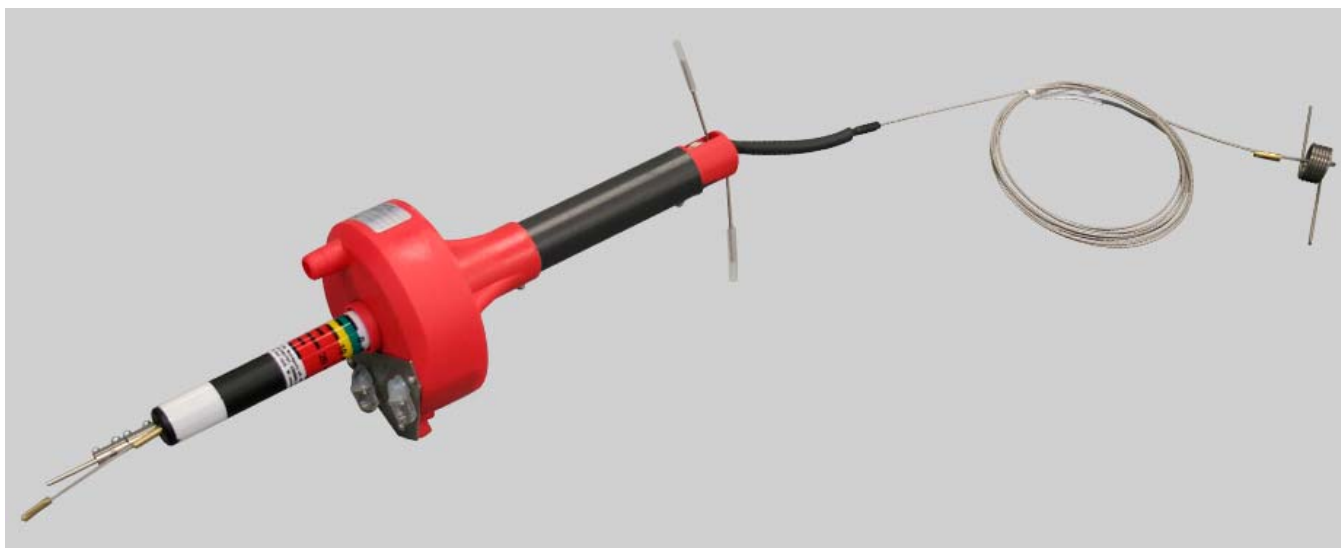
**Figure 12: Example Telltale Device**

It is also recommended that mechanical telltale monitoring devices be installed in the roof rock in several areas near the interface between the tunnels and natural cavern. These devices are relatively low cost, visual tools for monitoring movement in a tunnel roof. They are installed in vertical boreholes in the tunnel roof and spring anchors attached to wires are connected to a visual indicator measurement mechanism. Any dilation or bed separation of the strata will appear to pull the indicators along their axis showing how much the anchor has moved relative to the roof. Several options exist, including the Trolex RockMonitor XM Telltale, which are low profile and can be configured with up to four measurement heights, or Trolex RMT Auto-Warning Telltale (AWTT), as shown in Figure 12, which have a single anchor point but include LED's for indication of movement above a set threshold.

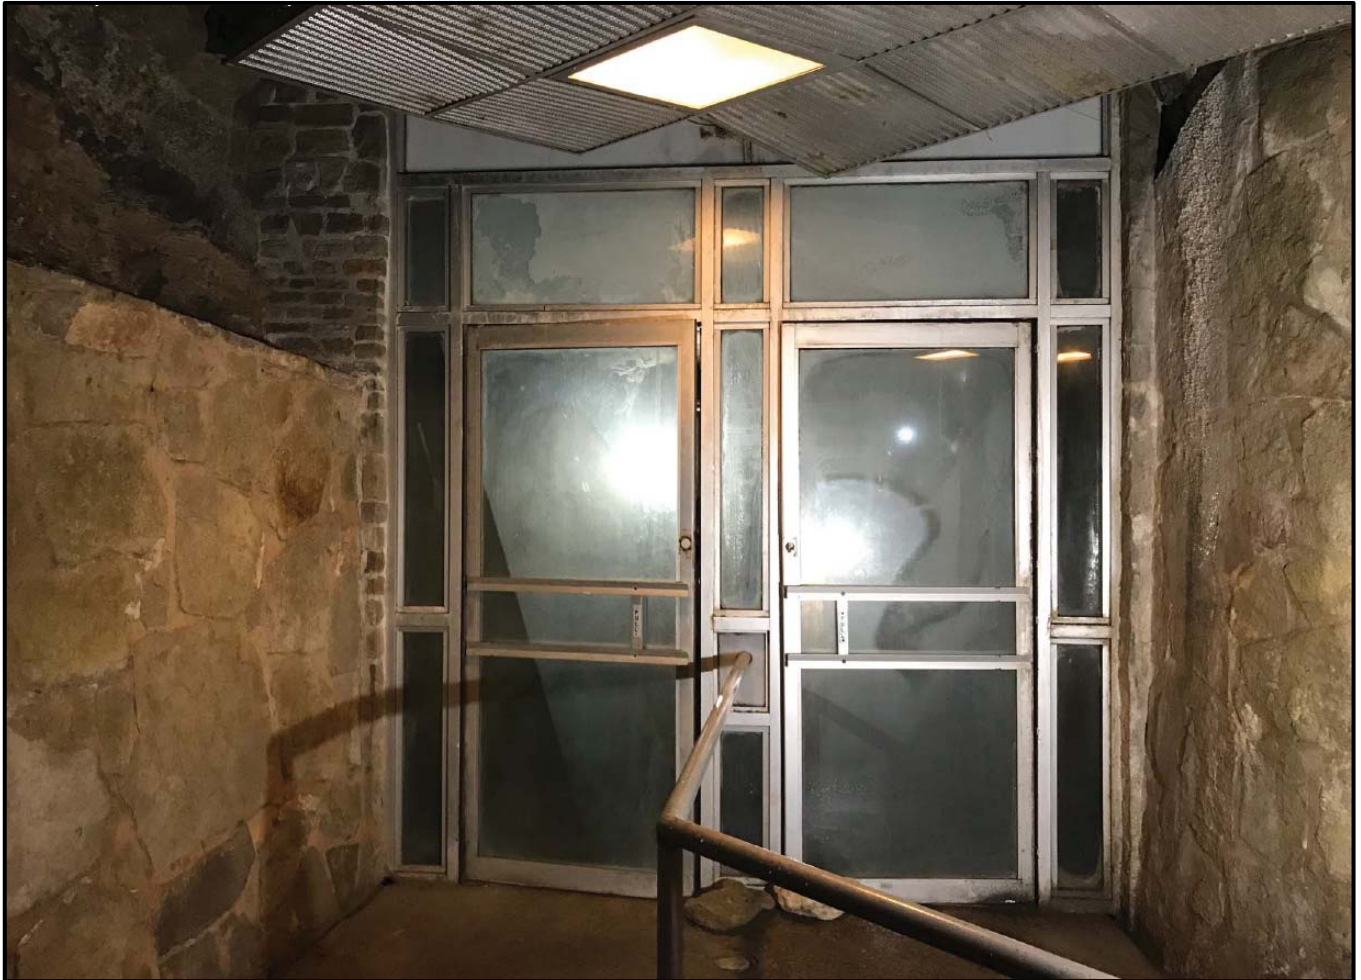
The existing condition of these doors is shown as Figure 20. Overall, the masonry wall bulkhead appears to be in good structural condition as no major visible cracks were observed during the Site investigation. If the bulkhead is found to require replacement during demolition of the door and frame, a masonry stone bulkhead could be constructed as a replacement using natural cave material and internal structural beam for support around the door frame. If insufficient natural cave material is available for all applications, similar limestone material should be available in the area. Overhead utility ports are present and should be replaced with transom panel.

**Figure 20: Dripstone Cave Entrance – Outer Airlock Doors (Existing Conditions).** Existing stacked stone masonry bulkhead visible on left side of doors.

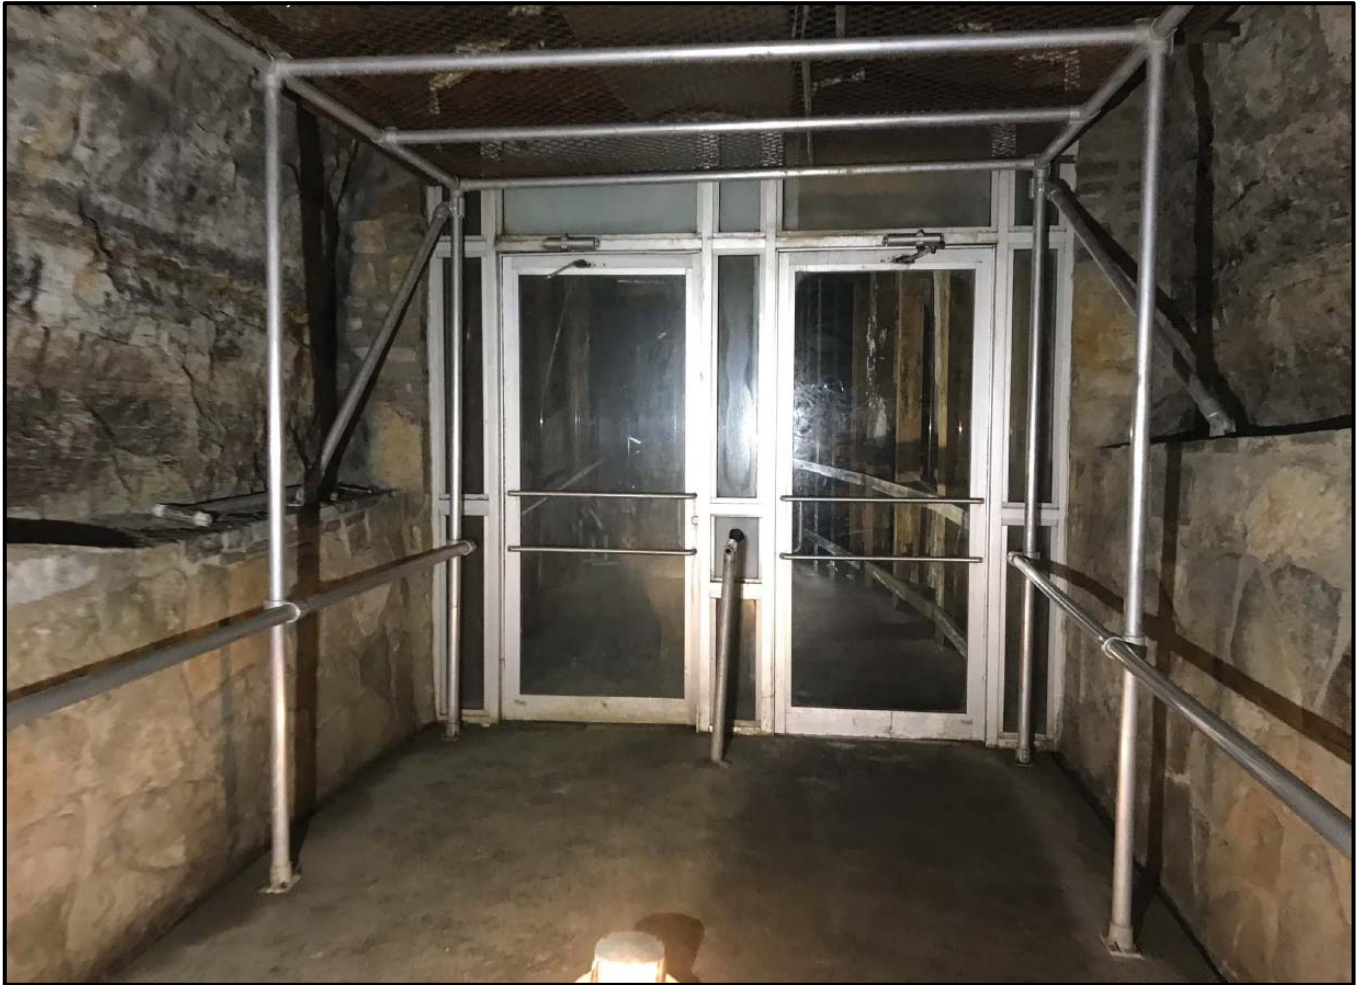
Figure 21: Dripstone Cave Entrance – Inner Airlock Doors (Existing Conditions)

The existing condition of these doors is shown as Figure 21. Overall, the masonry wall bulkhead appears to be in good structural condition as no major visible cracks were observed during the Site investigation. If the bulkhead is found to require replacement during demolition of the door and frame, a masonry stone bulkhead could be constructed as a replacement using natural cave material and an internal structural beam for support around the door frame. Overhead utility ports are present and should be replaced with transom panel.

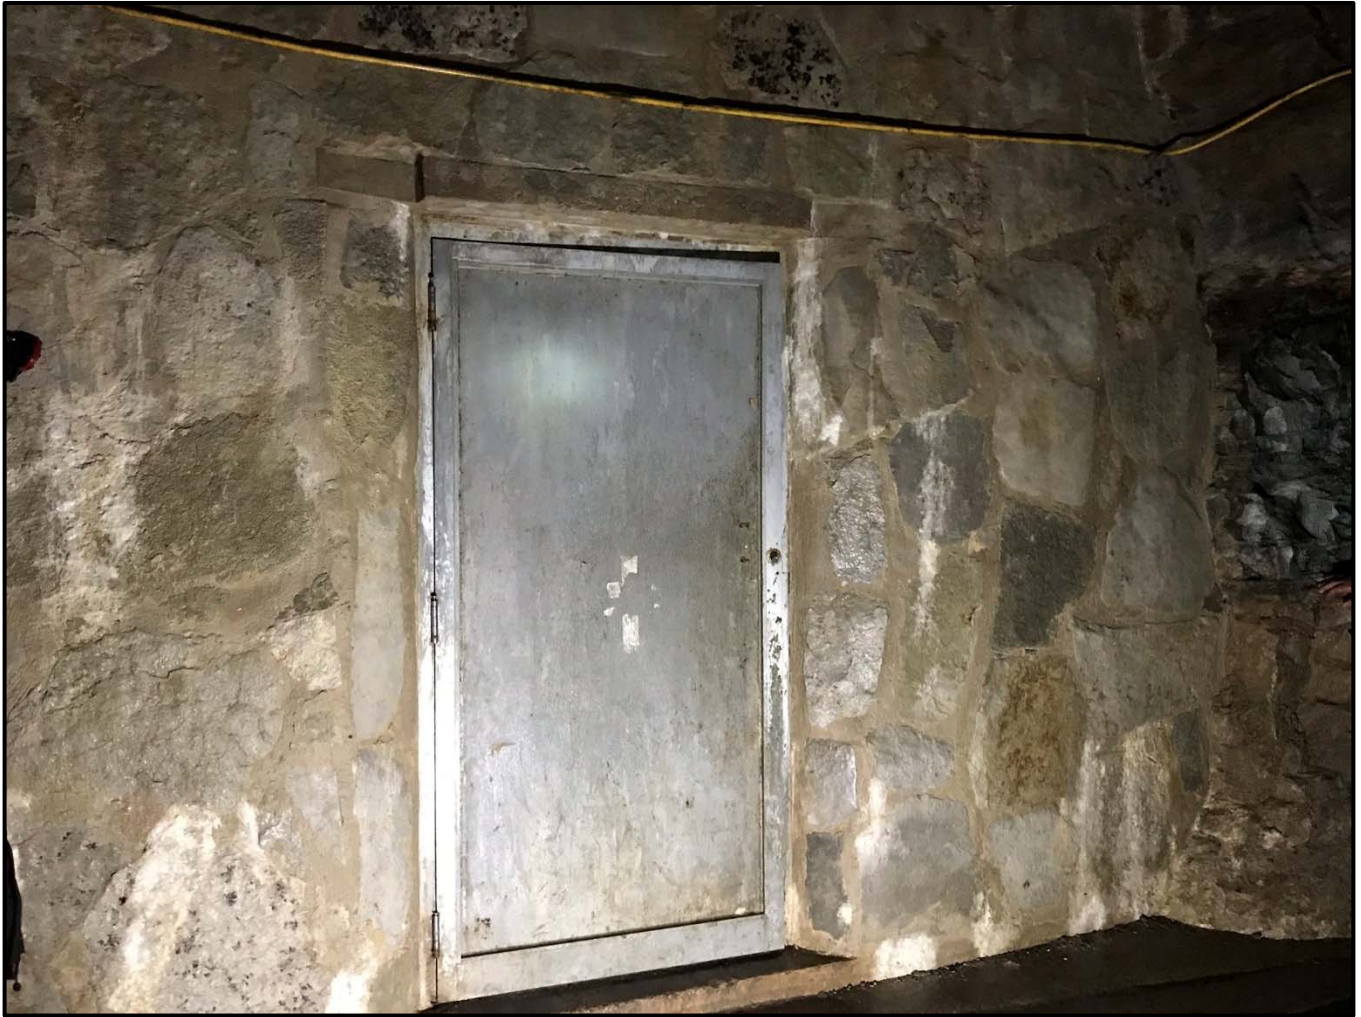
Figure 22: Dripstone Cave Bypass Tunnel Door (Existing Conditions)

The existing condition of this door is shown as Figure 22. Overall, the masonry wall appears to be in good structural condition as no major visible cracks were observed during the Site investigation. The masonry wall provides good aesthetic appeal and is recommended to remain in place without modification.

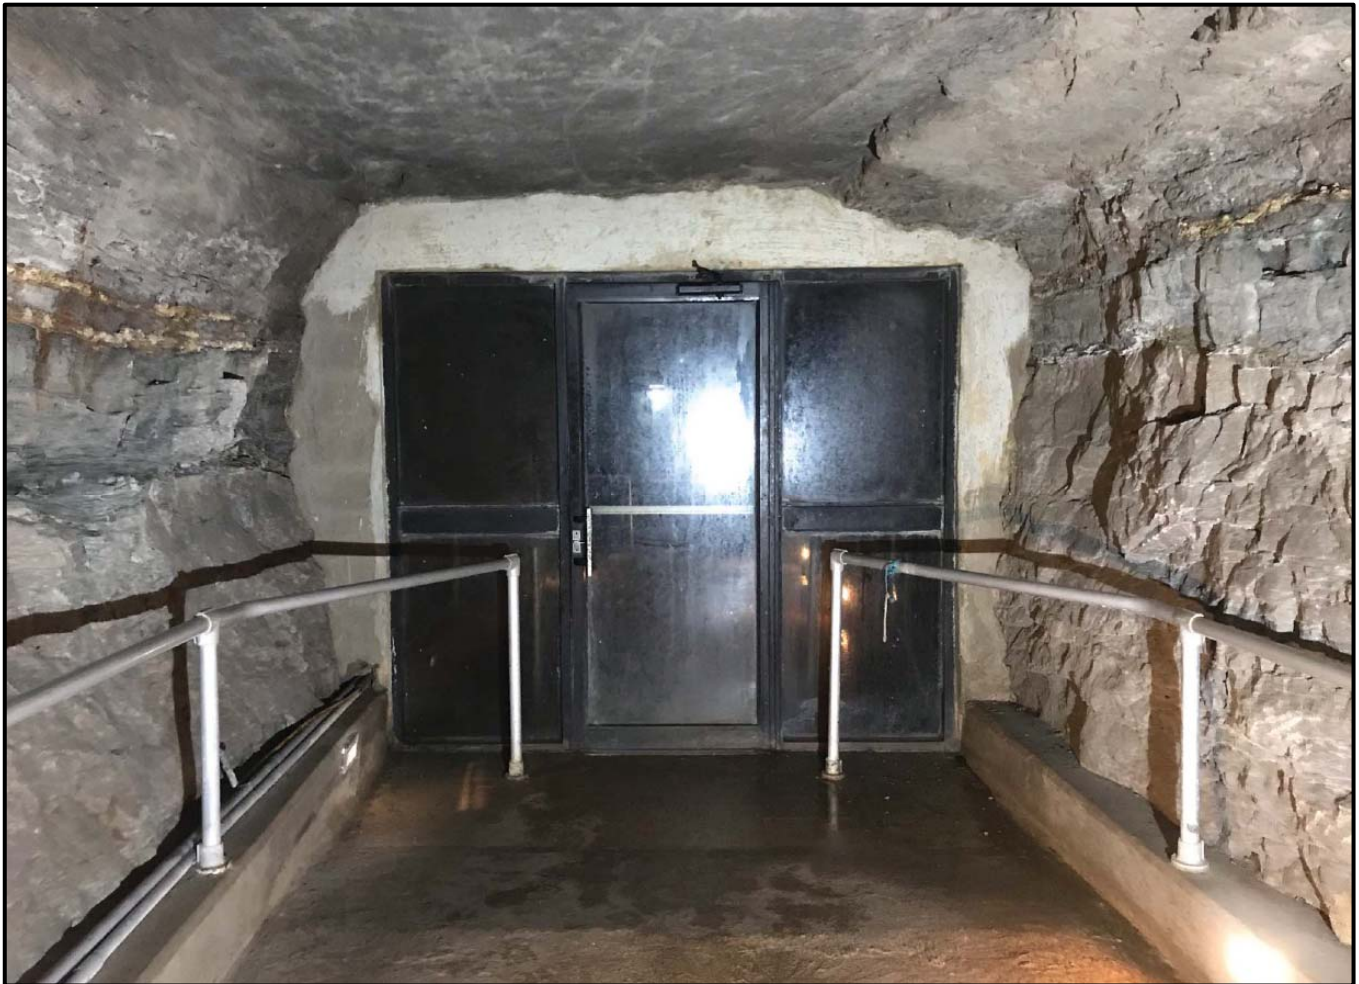
Figure 23: Dripstone Cave Exit – Inner Airlock Door (Existing Conditions)

The existing condition of this door is shown as Figure 23. Overall, the concrete wall bulkhead appears to be in good structural condition as no major visible cracks were observed during the Site investigation. If the bulkhead is found to require replacement during demolition of the door and frame, a masonry stone bulkhead could be constructed as a replacement using natural cave material and an internal structural beam for support around the door frame. Utility ports are present and should be replaced if bulkhead requires replacement.

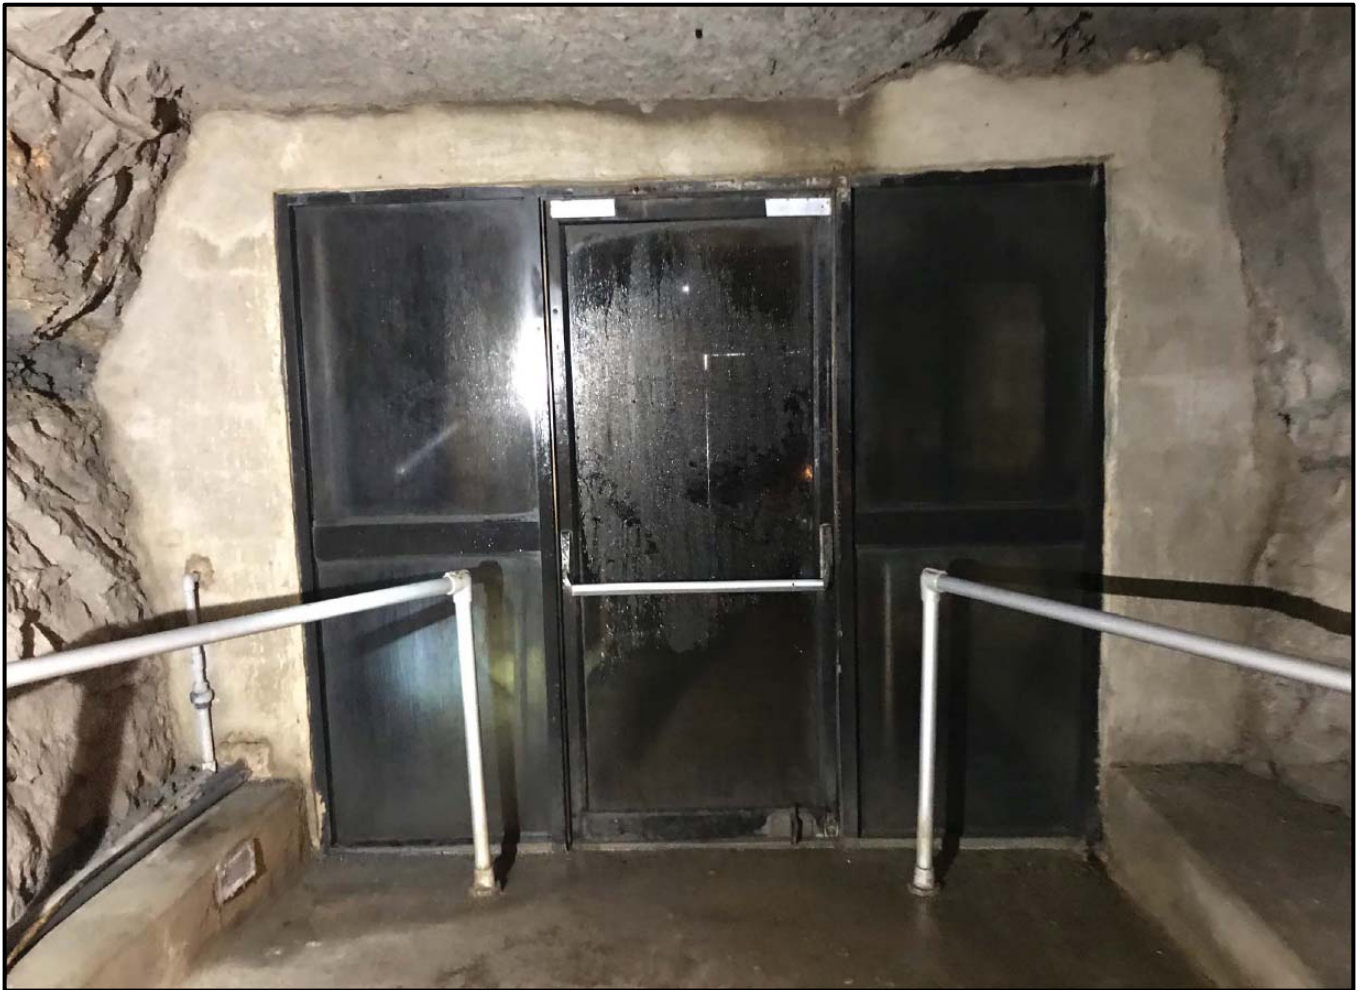
Figure 24: Dripstone Cave Exit – Outer Airlock Door (Existing Conditions)

The existing condition of this door is shown as Figure 24. Overall, the concrete wall bulkhead appears to be in good structural condition as no major visible cracks were observed during the Site investigation. If the bulkhead is found to require replacement during demolition of the door and frame, a masonry stone bulkhead could be constructed as a replacement using natural cave material and an internal structural beam for support around the door frame. Utility ports are present and should be replaced if bulkhead requires replacement.

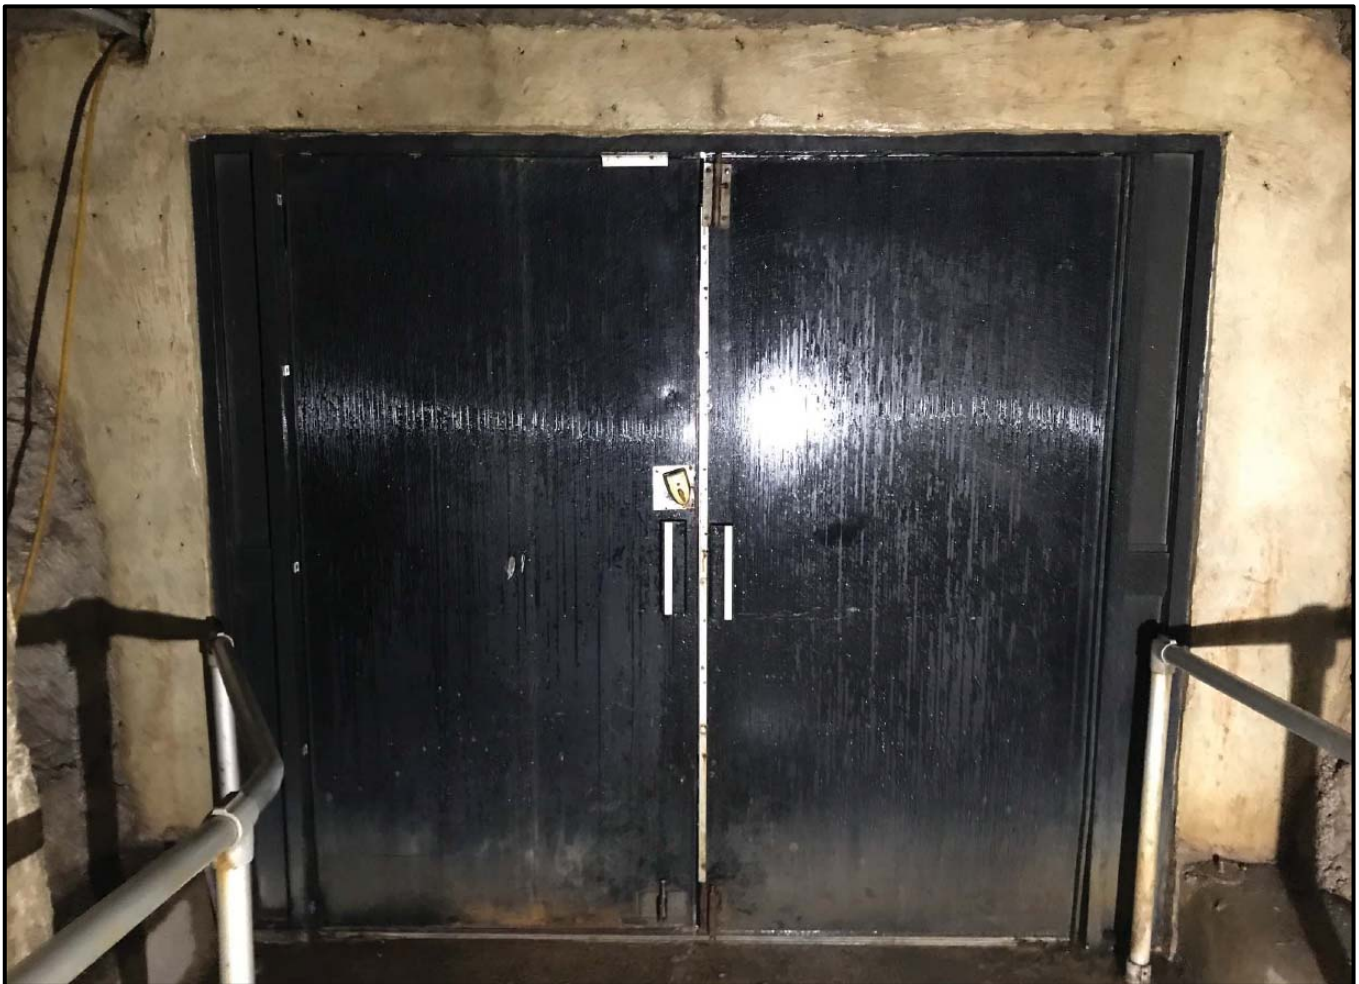
Figure 25: Dripstone Cave Exit - Security Doors (Existing Conditions)

The existing condition of these doors is shown as Figure 25. Overall, the concrete wall bulkhead appears to be in good structural condition as no major visible cracks were observed during the Site investigation. If the bulkhead is found to require replacement during demolition of the door and frame, a masonry stone bulkhead could be constructed as a replacement using natural cave material and an internal structural beam for support around the door frame. The bulkhead color is contrasting and refinishing is recommended with a color which more closely matches the surrounding cave rock and concrete floor. Utility ports are present and should be replaced if bulkhead requires replacement.

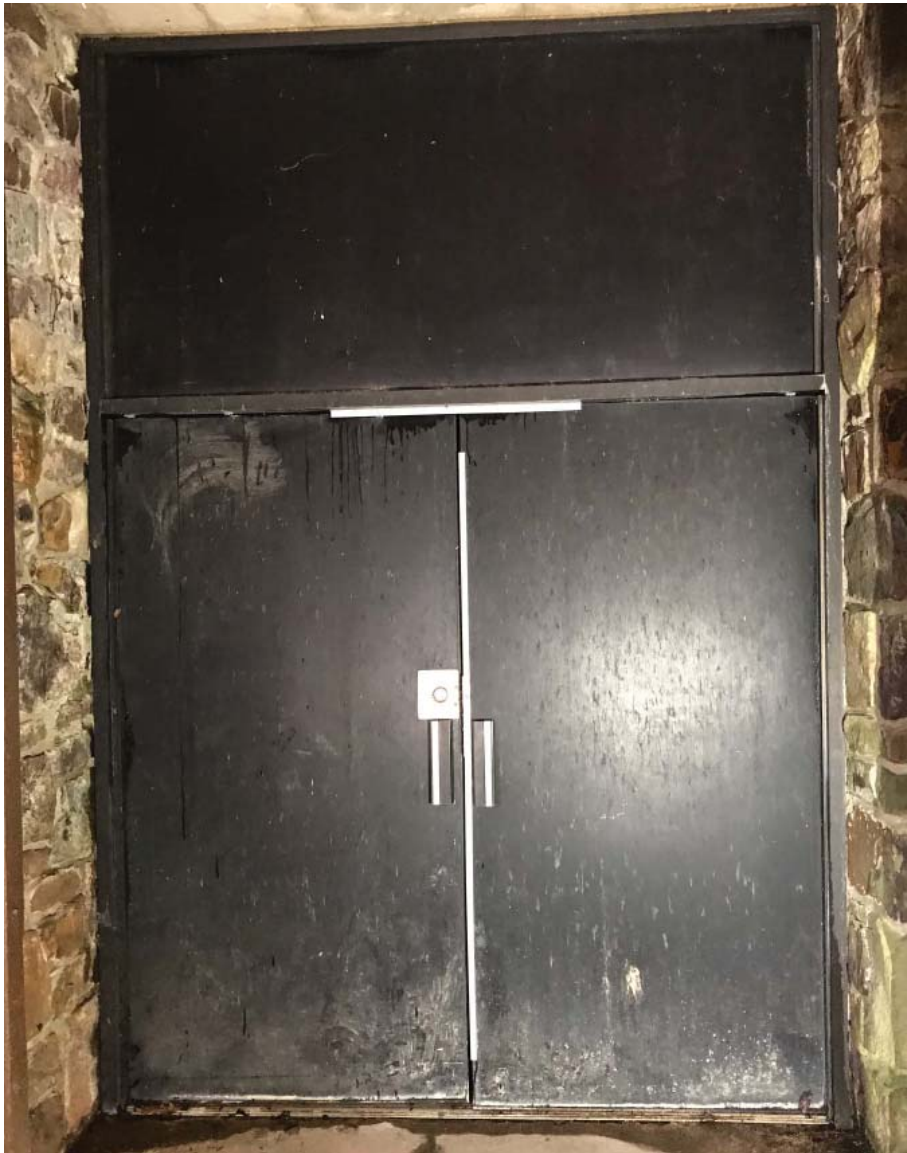
Figure 26: Discovery Cave Exit - Security Doors (Existing Conditions)

The existing condition of these doors is shown as Figure 26. Overall, the masonry wall appears to be in good structural condition as no major visible cracks were observed during the Site investigation. The masonry wall provides good aesthetic appeal and is recommended to remain in place without modification.

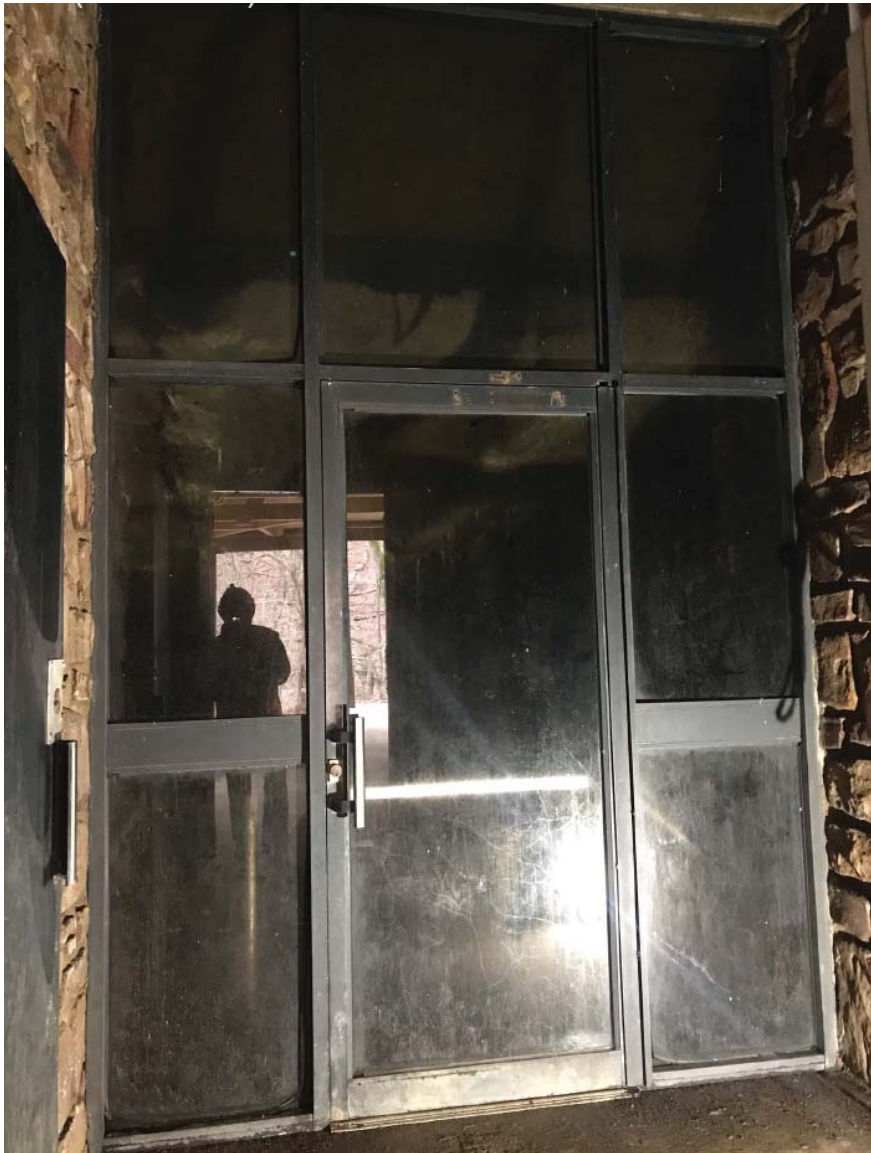
Figure 27: Discovery Cave Exit – Outer Airlock Door (Existing Conditions)

The existing condition of this door is shown as Figure 27. Overall, the masonry wall appears to be in good structural condition as no major visible cracks were observed during the Site investigation. The masonry wall provides good aesthetic appeal and is recommended to remain in place without modification.

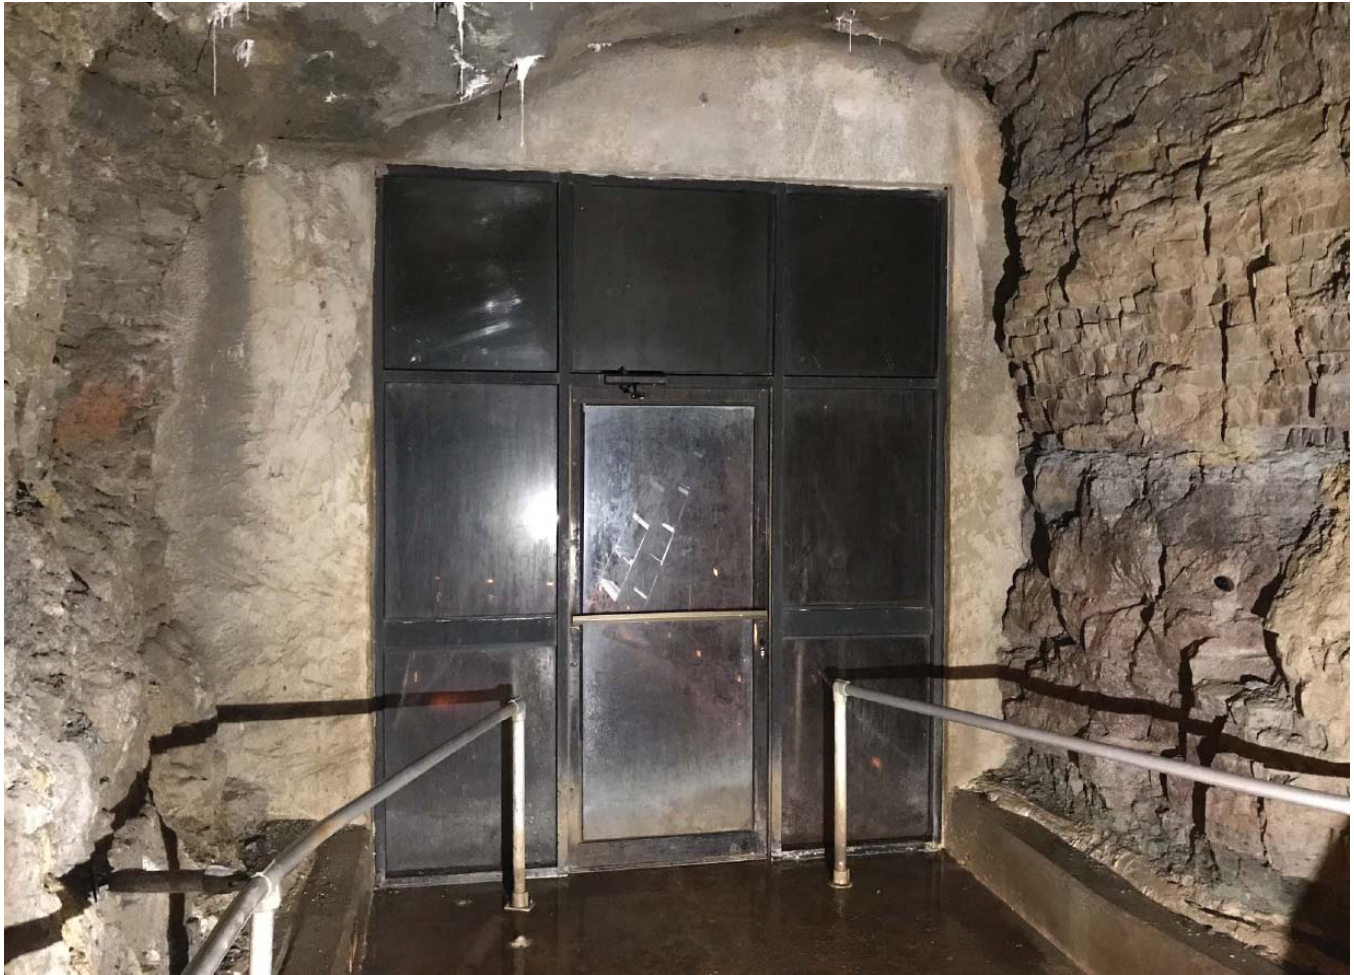
Figure 28: Discovery Cave Exit – Inner Airlock Door (Existing Conditions)

The existing condition of this door is shown as Figure 28. Overall, the concrete wall bulkhead appears to be in good structural condition as no major visible cracks were observed during the Site investigation. If the bulkhead is found to require replacement during demolition of the door and frame, a masonry stone bulkhead could be constructed as a replacement using natural cave material and an internal structural beam for support around the door frame.
