## REGULATED BUILDING MATERIALS SURVEY REPORT-DESIGN GEOTHERMAL HVAC SYSTEM FOR THE JACKSON SHRINE DEATH SITE (SJDS)

NPS-GSA Northeast Fredericksburg and Spotsylvania National Military  
Park – CBF Jackson Shrine  
12019 Stonewall Jackson Road Woodford, Virginia 22580

Mabbett Project No. R2020001.005  
FMSS #23801

August 30, 2024

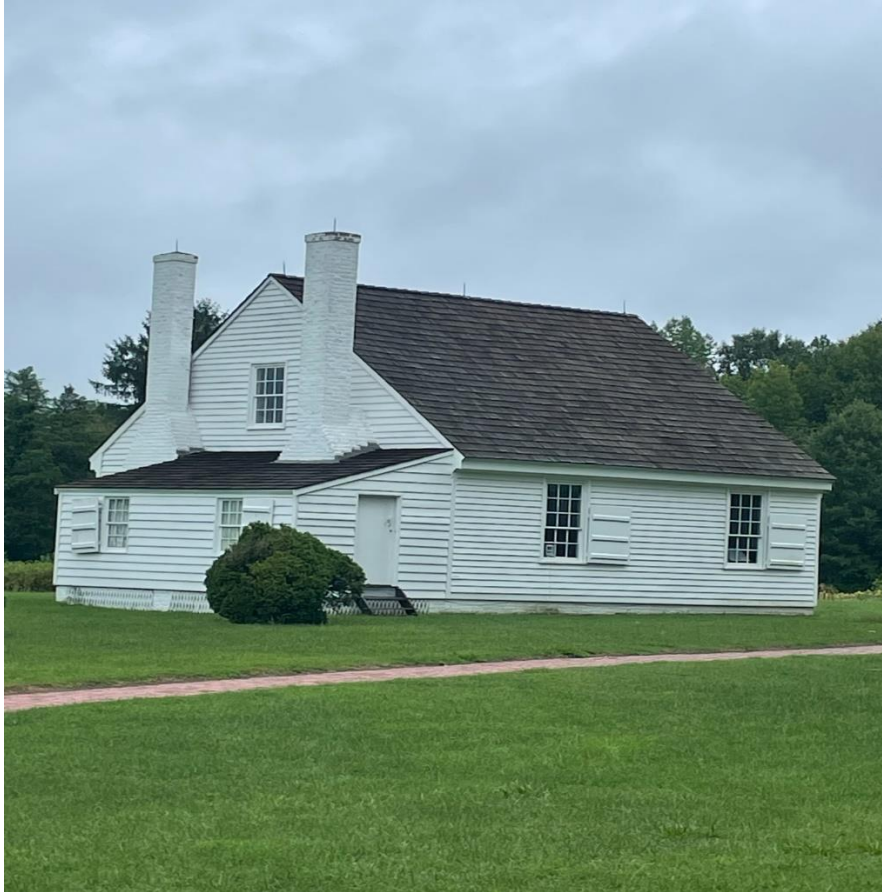
*Photograph 1 - Jackson Shrine Death Site house structure.*

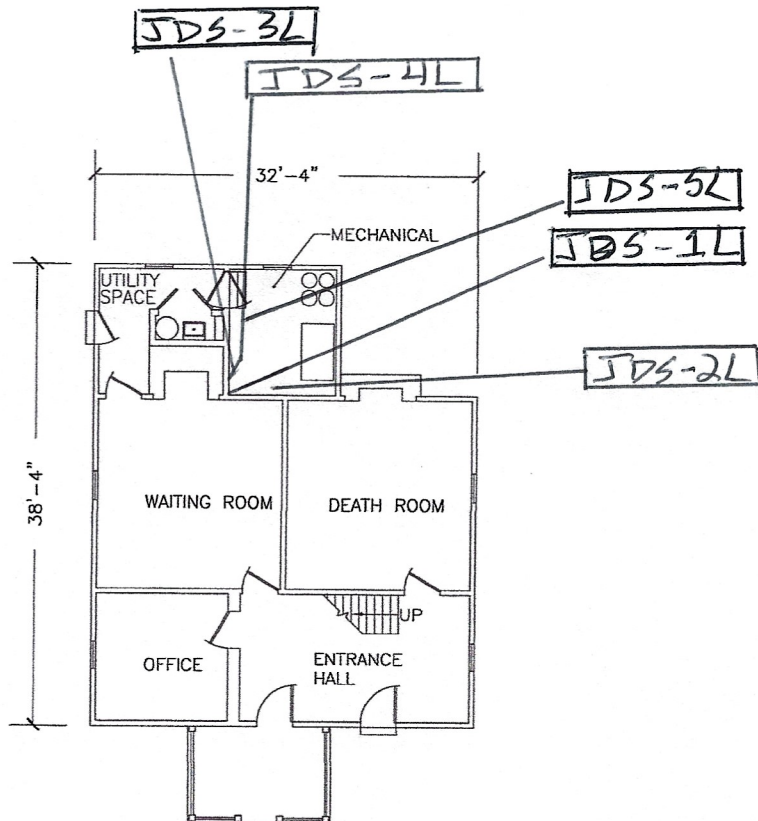
NPS-GSA NORTHEAST  
FREDERICKSBURG AND SPOTSYLVANIA  
NATIONAL MILITARY PARK  
FMSS #23801  
CBF JACKSON SHRINE  
FIRST FLOOR

| <b>TABLE 2</b><br><b>Summary of Lead Paint Chip Analytical Results</b><br><b>Stonewall Jackson Shrine Death Site</b><br><b>Woodford, VA</b> | | | |
|---|---|---|---|
| JDS-1L | Mechanical Room-At Entrance to Crawl Space-Clapboard | Chip | 1.9% |
| JDS-2L | Mechanical Room-At Entrance to Crawl Space-Clapboard | Chip | 6.5% |
| JDS-3L | Mechanical Room-Near Entrance to Crawlspace-Brick | Chip | 0.91% |
| JDS-4L | Mechanical Room-Near Entrance to Crawlspace-Brick | Chip | 2.3% |
| JDS-5L | Mechanical Room-Near Entrance to Crawlspace-Drywall Wall | Chip | 1.7% |

LEAD SAMPLING
