July 8, 2025

RE:           Lead-Based Paint Survey 12 Buildings  
              4 Lazy F Ranch  
              4 Lazy F Ranch Road  
              Moose, Wyoming  
              Northern Industrial Hygiene Project No. 999-5237

This letter report provides the summarized results of the lead-based paint (LBP) survey conducted by Chris Hust of Northern Industrial Hygiene, Inc. (Northern) on May 20, 2025, and May 21, 2025, at the above referenced site. The survey was conducted to identify potential LBP and lead-containing paint (LCP) that may be present on the interior and exterior finishes of the 12 buildings that will be impacted by the upcoming renovation project.

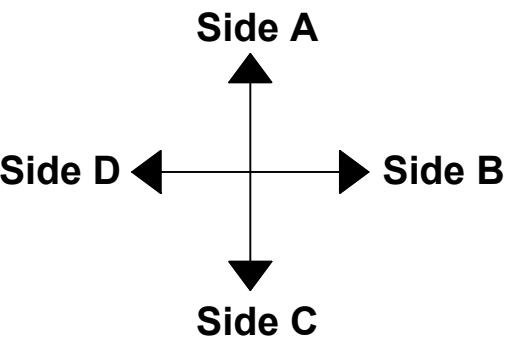
LBP LOCATION DRAWING  
MRS. OLIVER'S CABIN

- ① LBP on Exterior Window Components
- ② LBP on Exterior Door Components
- ③ LBP on Interior Window Sash
- ④ LBP on Crawlspace Hatch

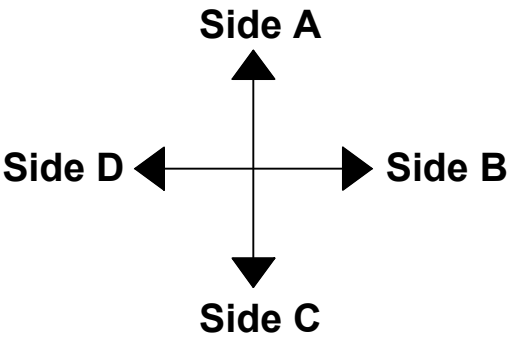
LBP LOCATION DRAWING  
MIDDLE CABIN

- ① LBP on Exterior Window Components
- ② LBP on Exterior Door Components
- ③ LBP on Interior Window Sash

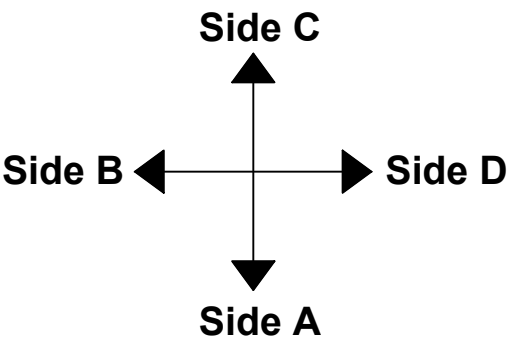
LBP LOCATION DRAWING  
NURSE'S CABIN

- ① LBP on Exterior Window Components
- ② LBP on Exterior Door Components

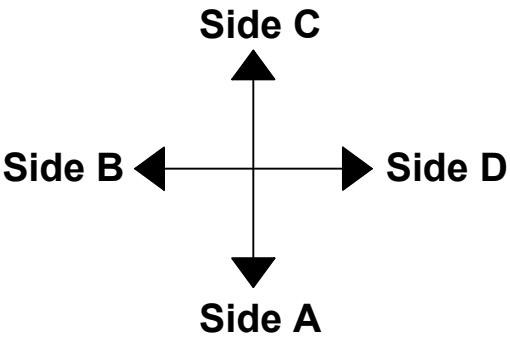
LBP LOCATION DRAWING  
MAIN LODGE

- ① LBP on Exterior Window Components
- ② LBP on Exterior Door Components
- ③ LBP on Interior Window Components
